**Mi BUILDING SURVEY**

# BUILDING SURVEY REPORT

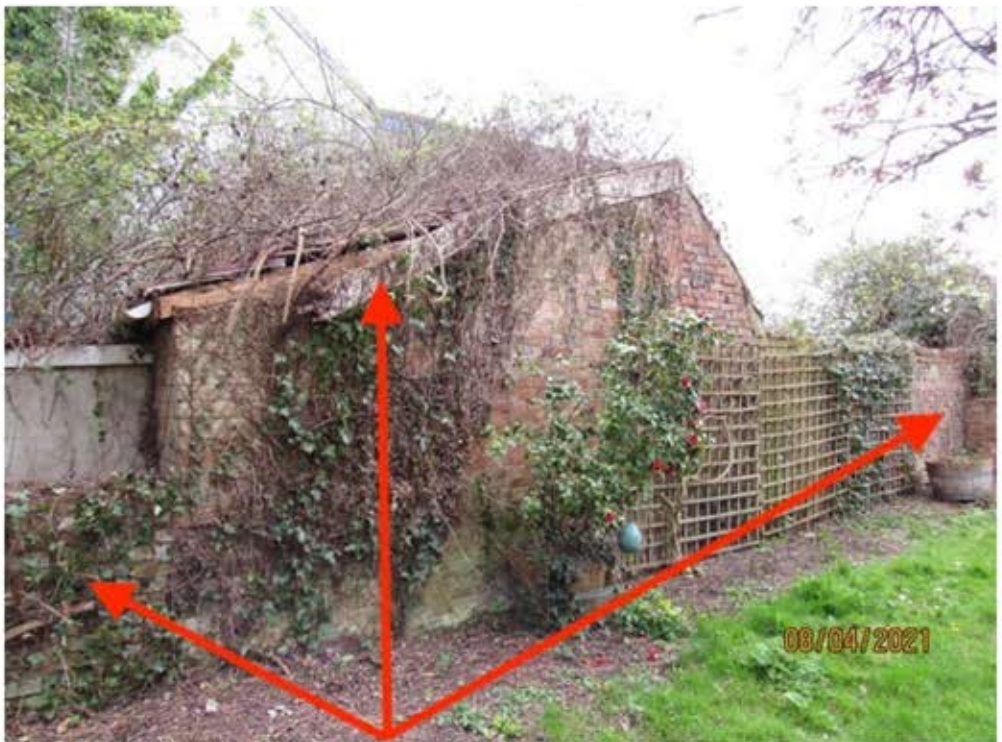
Poor condition of old brick walls and east elevation of neighbour's building

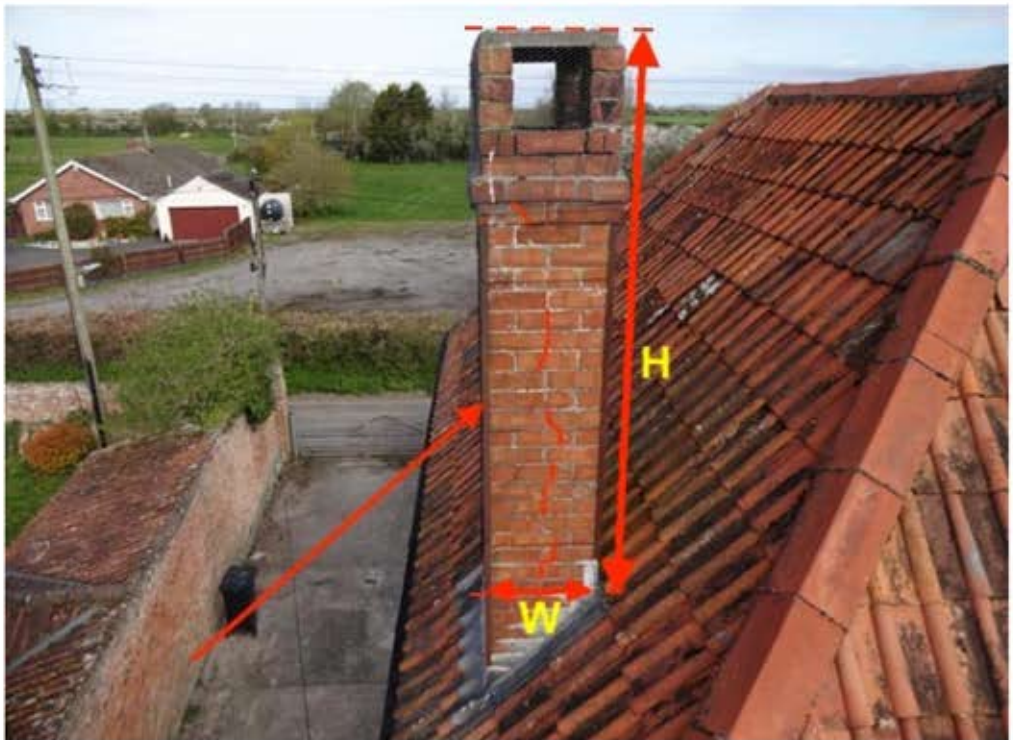
**A condition rating 3 has been applied to this section due to the requirement for further investigation by a chimney specialist.**

Vertical cracking in brickwork of west chimney stack, metal binders and slenderness ratio estimated at 4.35

<p><b>Action Required</b></p>	<p>1. It is strongly recommended that you commission a chimney specialist to advise on the condition of the west chimney stack and the slenderness ratios of both stacks.</p> <p>2. Request estimates for repair or rebuilding work of the west stack and any bracing requirements needed.</p> <p>3. The chimney stacks should be regularly monitored for any indications of damage, instability or other defects.</p> <p>4. You should carry out a thorough visual inspection at least once a year, ideally in the Spring, and ideally at roof level, to identify and repair any damage that could have been caused by winter weather.</p> <p>5. Ongoing maintenance:</p> <ul style="list-style-type: none"> <li>- Any future signs of missing, loose or defective mortar should be repointed as necessary.</li> <li>- Any moss or other accumulated plant matter should be cleared.</li> </ul>
<p><b>Additional Information</b></p>	<p>It would be prudent to combine the remedial works and maintenance in this section with those required in the sections below:</p> <ul style="list-style-type: none"> <li>- 4.2 Roof Coverings</li> <li>- 4.3 Rainwater and Above Ground Drainage Fittings</li> <li>- 4.5 Windows and External Doors</li> <li>- 4.6 External Joinery and Finishes</li> </ul>

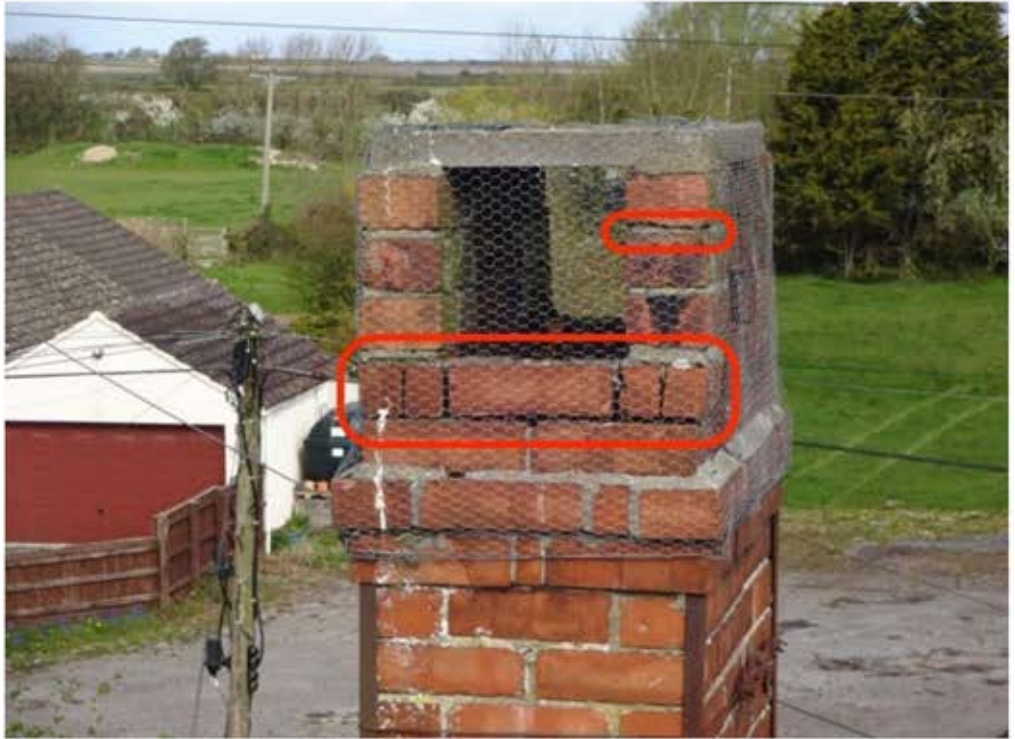
Missing mortar on west chimney stack

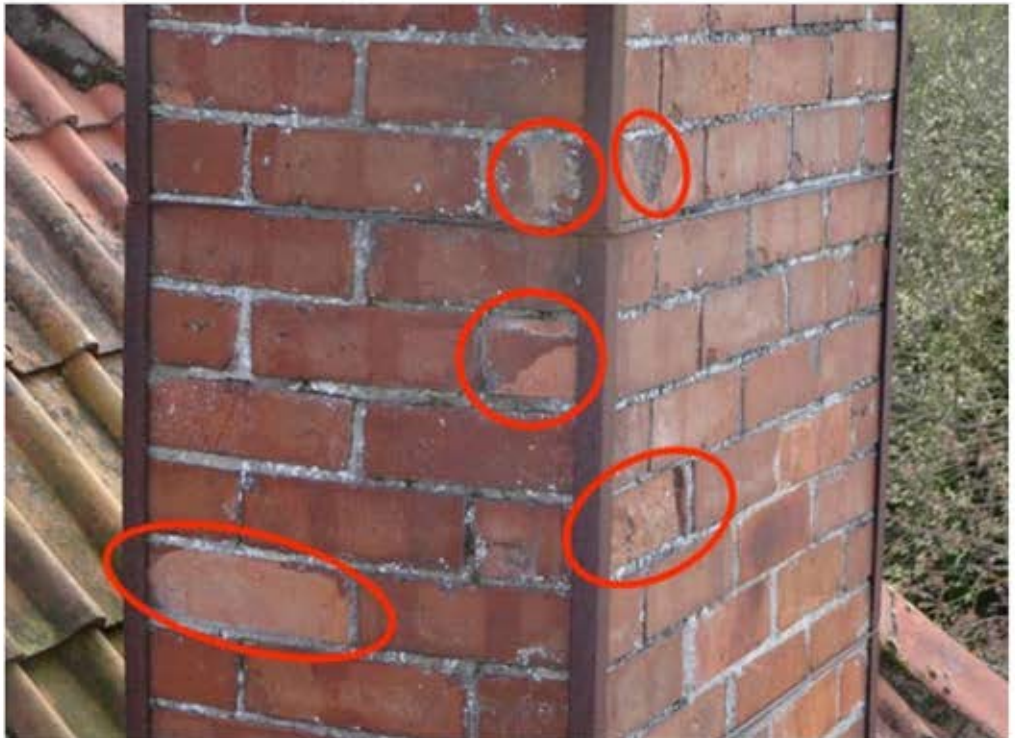
Spalling bricks on west chimney stack

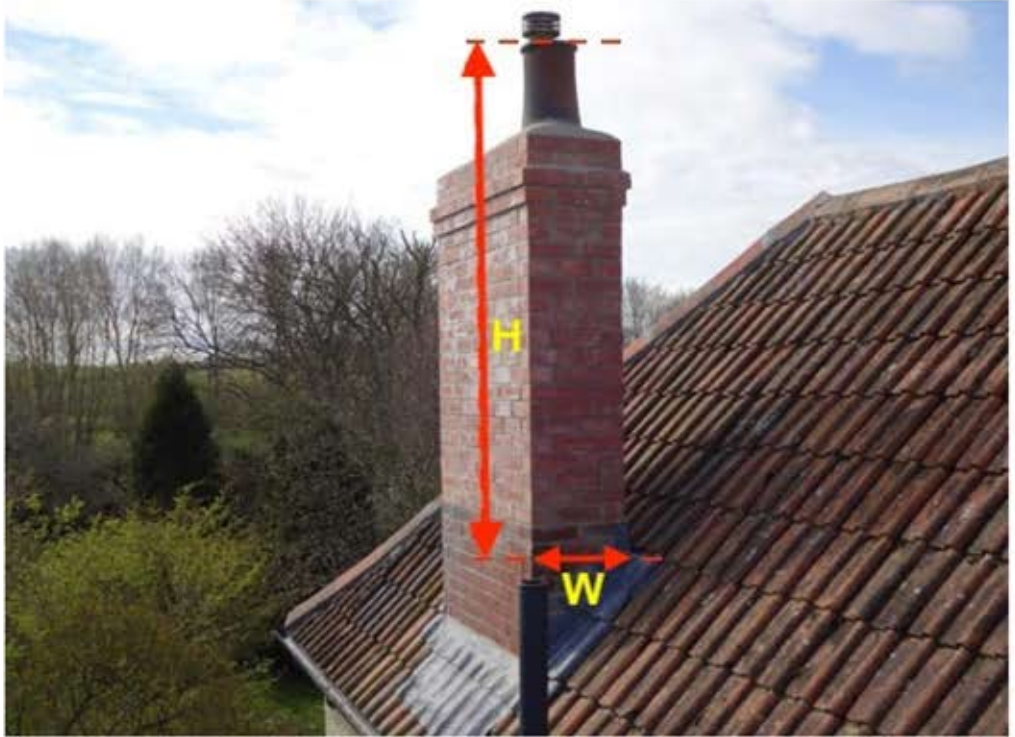
East chimney stack slenderness estimated at 4.5

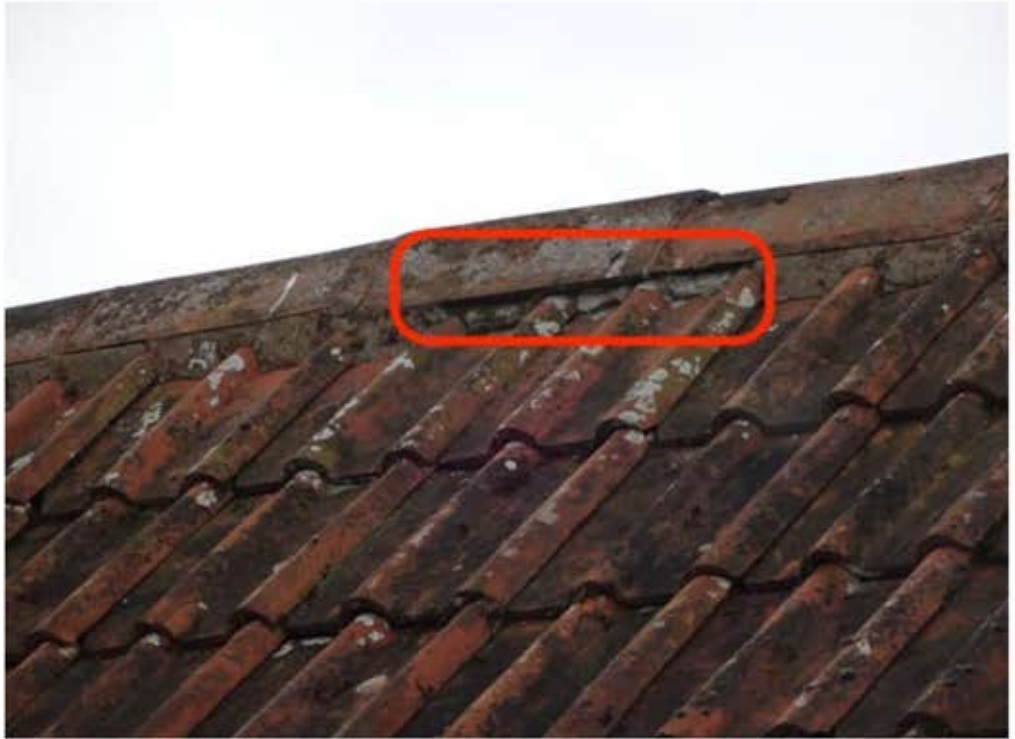
Missing mortar below ridge tiles on east slope

<p><b>Action Required</b></p>	<ol style="list-style-type: none"> <li>1. It is recommended that you request estimates for repair, replacement and improvement works required for the defects listed above.</li> <li>2. A plastic support tray system (eaves protector) should be installed above all the gutters to reduce the risk of water penetration leading to rot or other defects in nearby timbers. See image below.</li> <li>3. Ongoing maintenance: <ul style="list-style-type: none"> <li>- Any slipped, missing or broken tiles on the roof pitches should be repositioned, repaired or replaced.</li> <li>- Any missing mortar between and under the ridge tiles should be replaced.</li> <li>- Any moss or other accumulated plant matter should be cleared.</li> <li>- The central valley needs to be kept clear so that rainwater can be transferred away from the property as efficiently as possible.</li> </ul> </li> <li>4. You should carry out a thorough visual inspection of all roofs at least once a year, ideally in the Spring to identify and repair any damage that could have been caused by winter weather.</li> <li>5. You should anticipate that the roof coverings will require normal maintenance for the short term, but you should allow for recovering within 10-15 years, although, there is no evidence of significant failure at present.</li> <li>6. When any recovering is undertaken, the supporting timbers may also need some attention. The underlay should be replaced at that time also.</li> </ol>

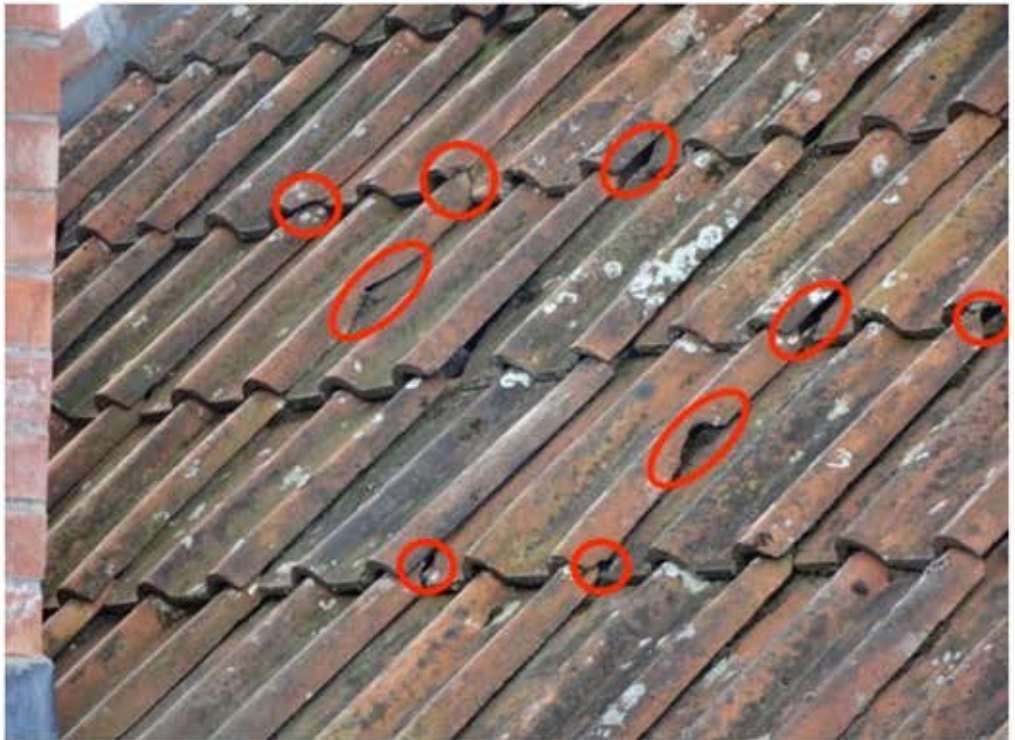
Cracked tiles on east slope

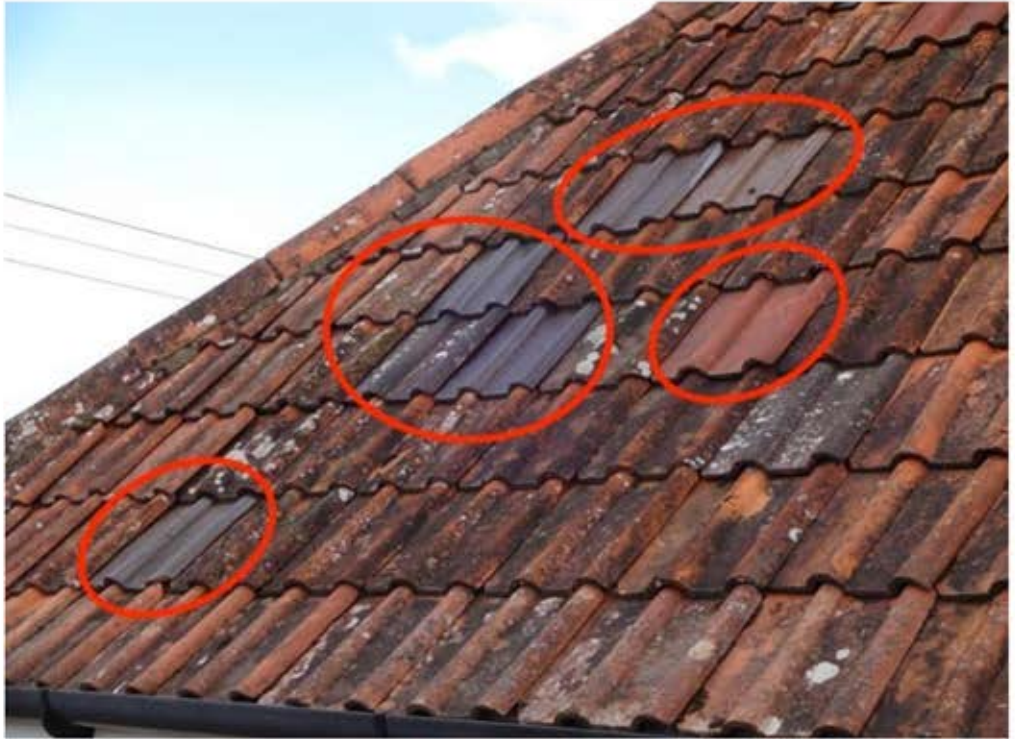
Numerous replacement tiles

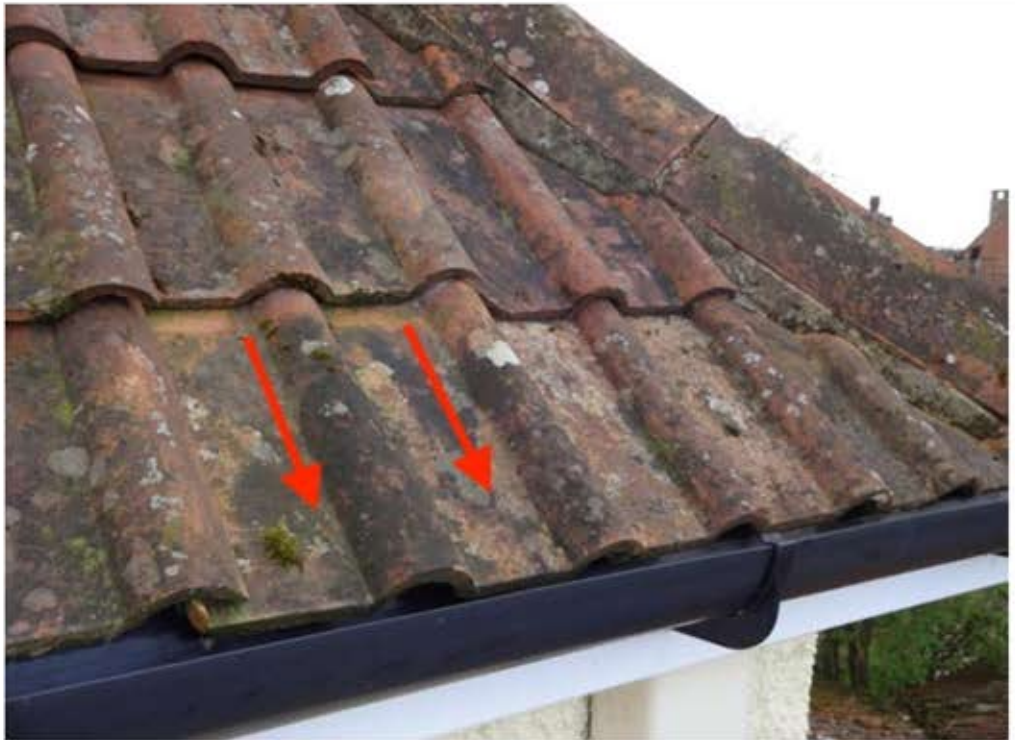
Slipped tiles above gutter

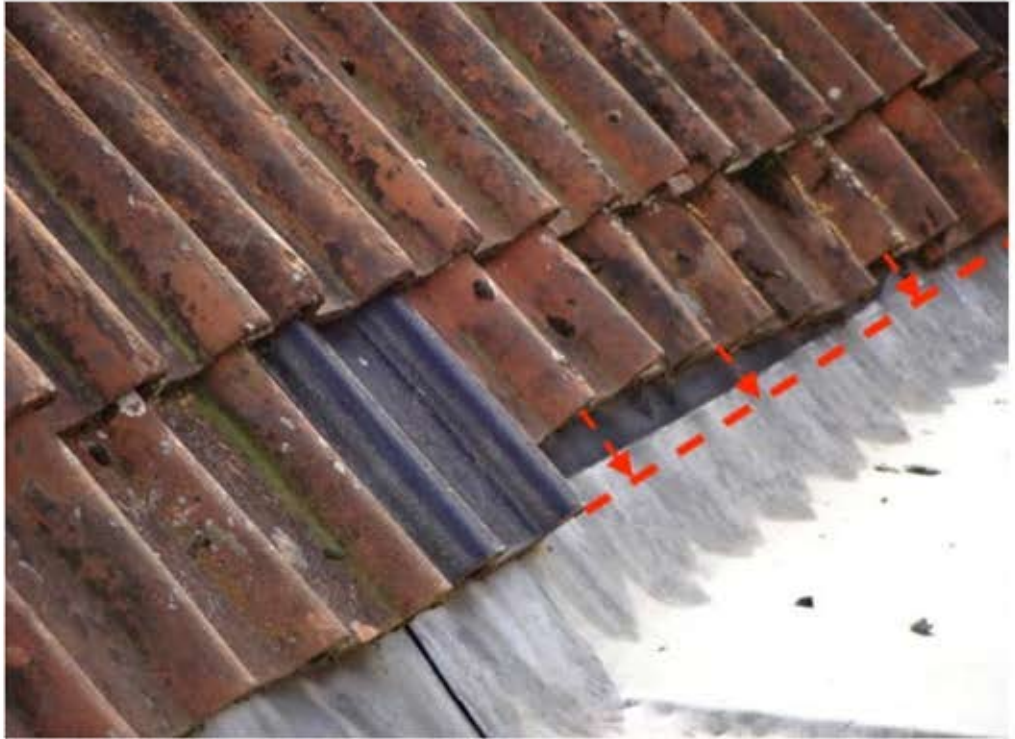
Tiles either broken or incorrectly fixed above central valley gutter

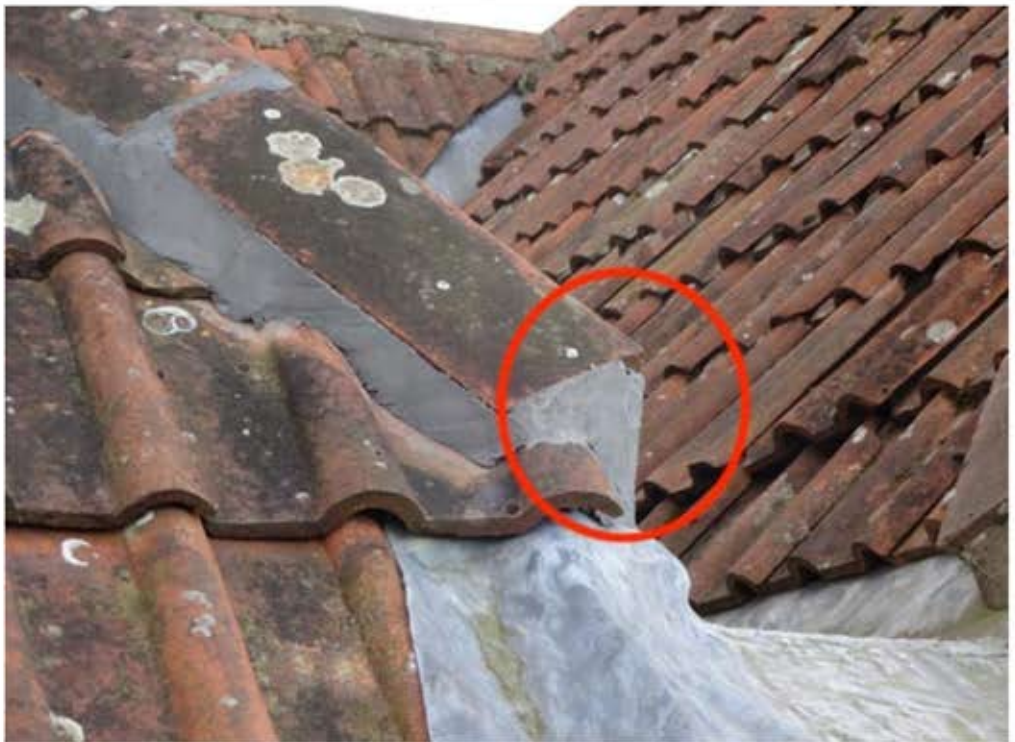
Missing hip iron to secure ridge end tile

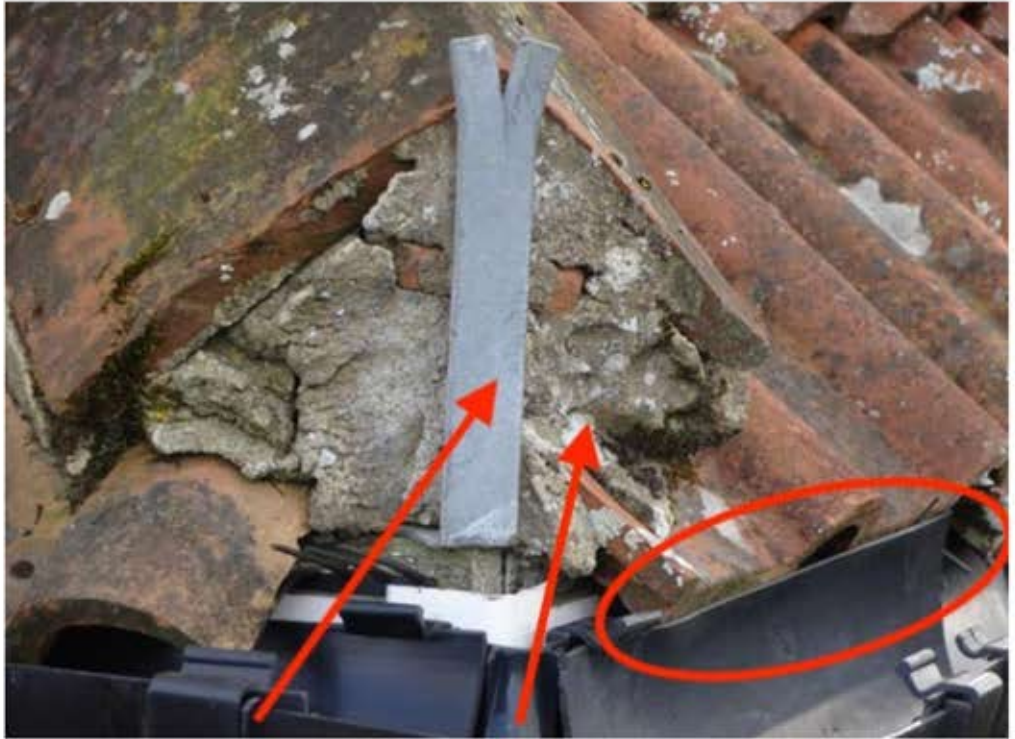
Poor workmanship at north-west corner

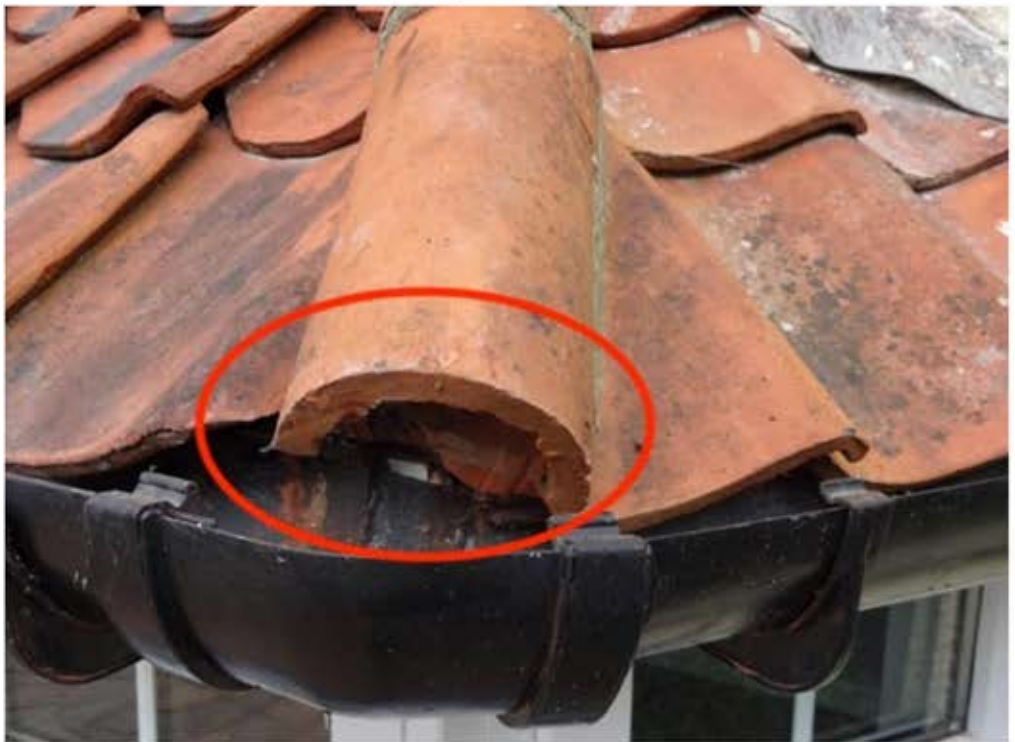
Missing hip iron on both corners of bay roof

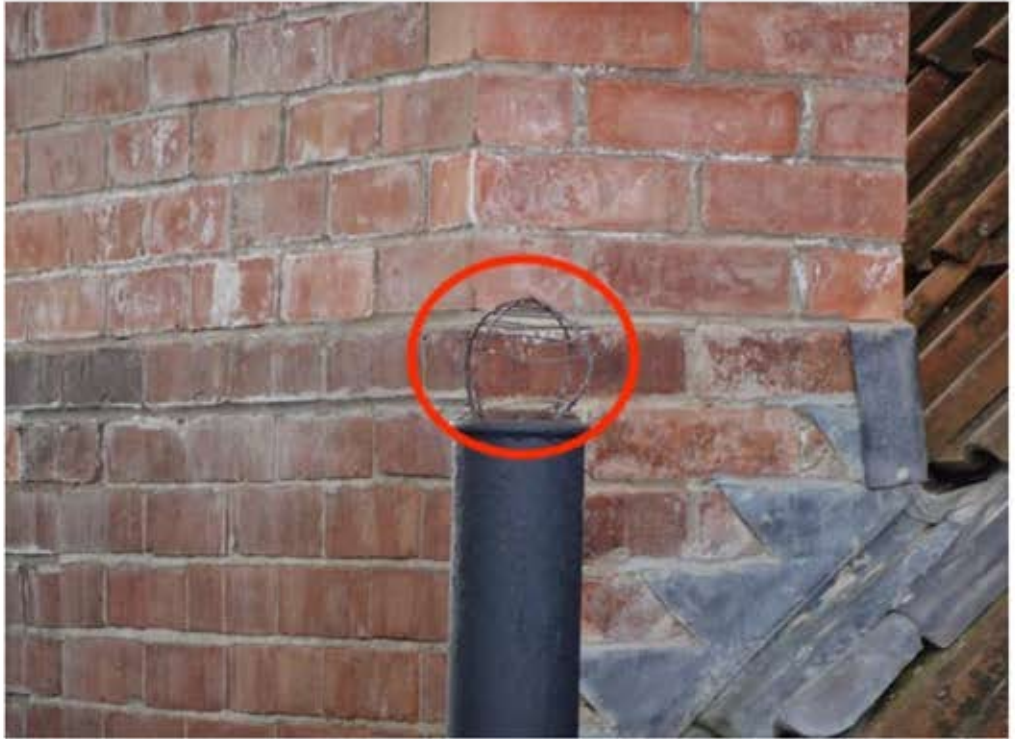
Old worn wire bird guard in east SPV

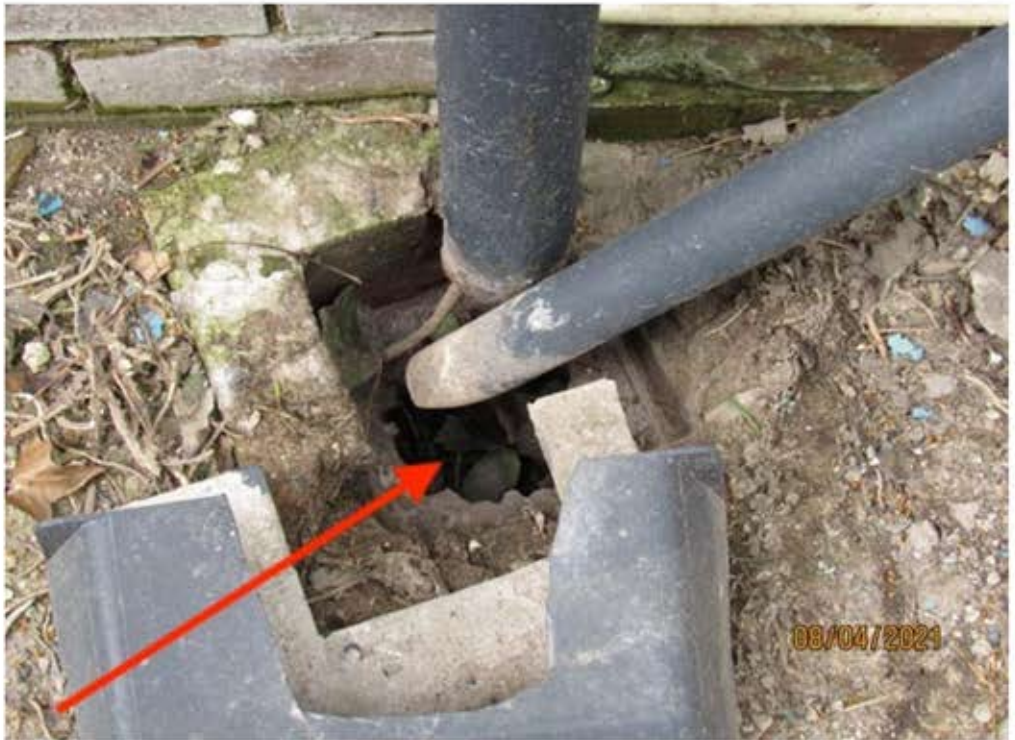
Poor condition of surface gully below east kitchen window

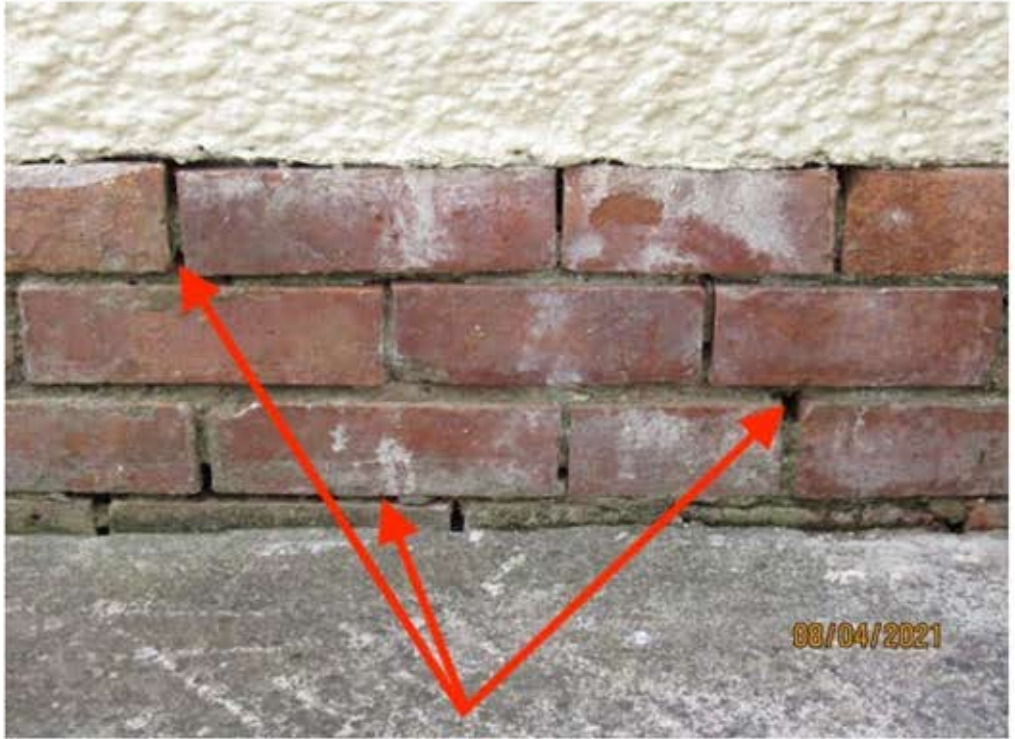
Missing mortar in various location of brick base

<p><b>Action Required</b></p>	<ol style="list-style-type: none"> <li>1. All loose or missing mortar around brickwork should be repointed.</li> <li>2. Any fine cracking should be raked out and repointed.</li> <li>3. All walls should be examined regularly to inspect for changes in the nature of any cracking or other defects that may become apparent.</li> <li>4. You should carry out a thorough visual inspection at least once a year, ideally in the Spring to identify and repair any damage that could have been caused by winter weather.</li> <li>5. It is recommended that the cavity wall ties are inspected as part of scheduled maintenance.</li> <li>6. It is recommended that the walls are inspected for the existence of cavity trays.</li> <li>7. You may wish to seek the advice of a cavity wall specialist regarding adding cavity wall insulation. They may advise avoiding adding insulation to west facing walls due to the prevailing weather in this region.</li> <li>8. As will be discussed in section 5.4 Floors, if the condition of the areas of timber flooring are being affected by damp, fitting air bricks is strongly recommended.</li> </ol>

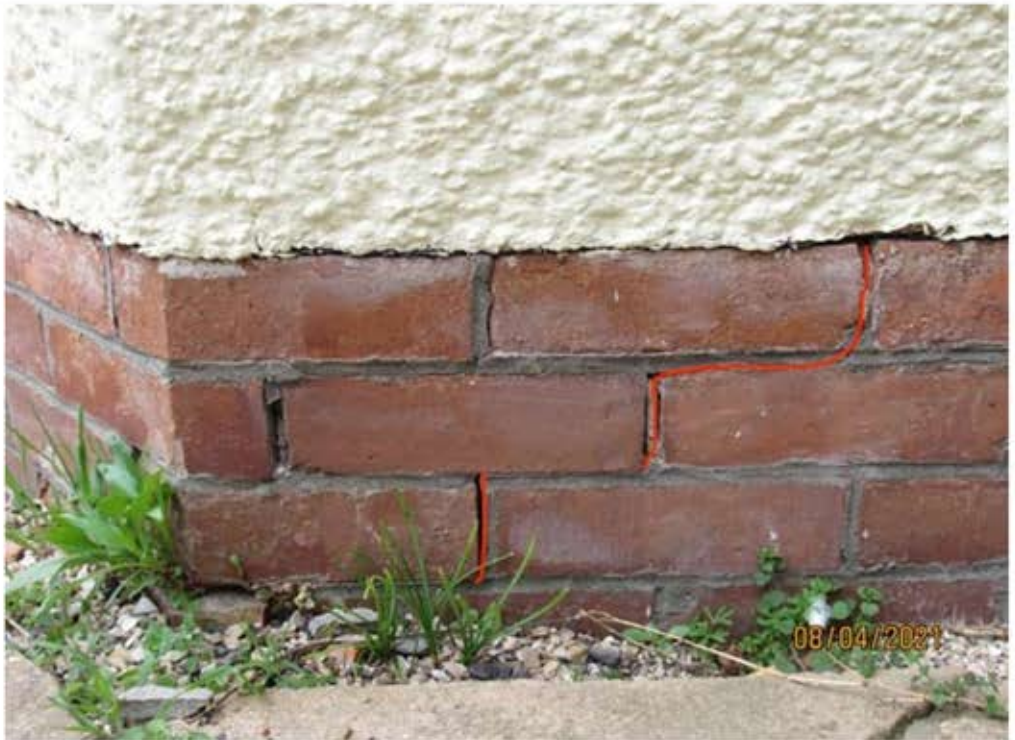
Fine cracking below east bay window

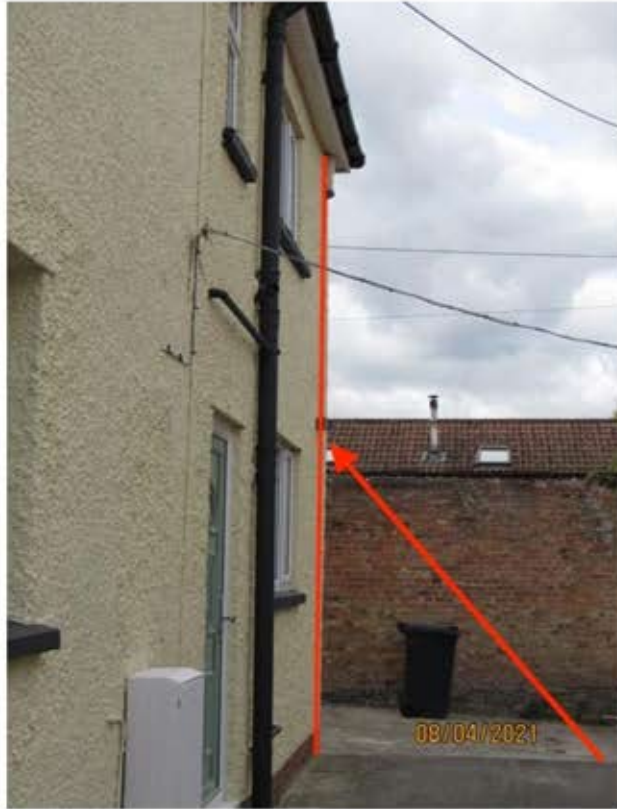
North-west wall bowing slightly

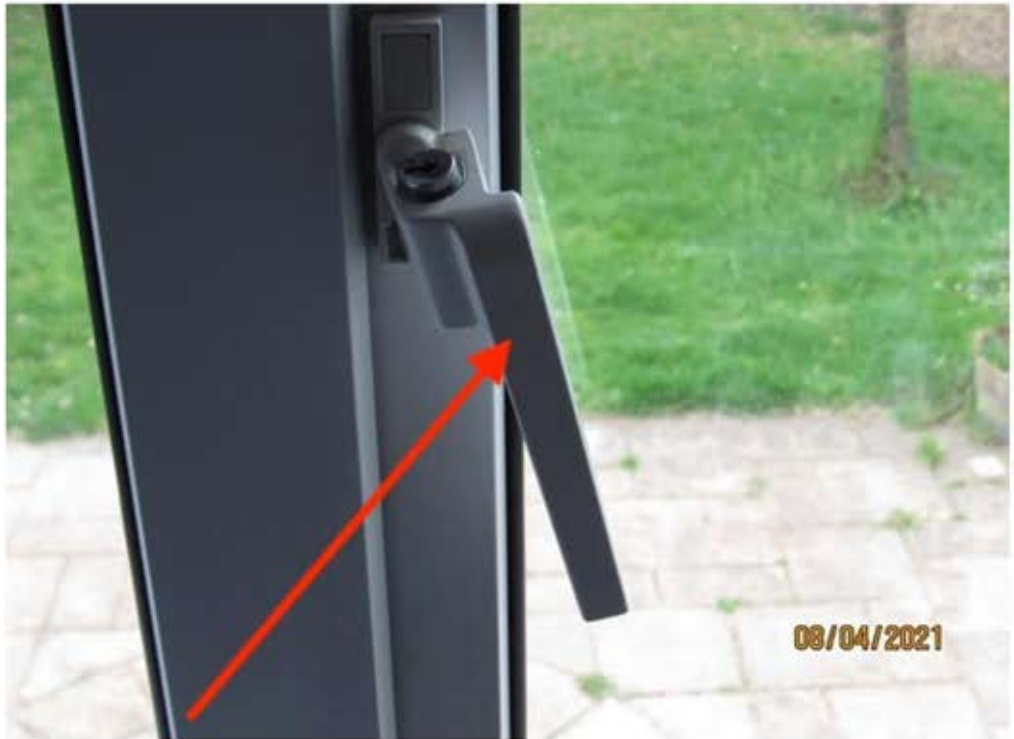
Very stiff handle in landing window

<p><b>Action Required</b></p>	<p>1. Normal maintenance of frames, hinges and locks is required.</p> <p>2. You should ask your legal adviser to check for any installation guarantees for the windows and doors.</p> <p>3. Be aware that previous owners may have distributed multiple sets of keys for the windows and doors to individuals not known to you. When purchasing a property, you should consider the cost of replacing all the door and window locks as soon as possible after you take up occupation. When doing this you should consult your insurers to ensure that you meet their requirements for security, and obtain any discounts that may be available by improving the security of the property.</p> <p>4. Once one window seal fails, others may follow in a short space of time. The windows may need replacing within 5 years.</p>
-------------------------------	--

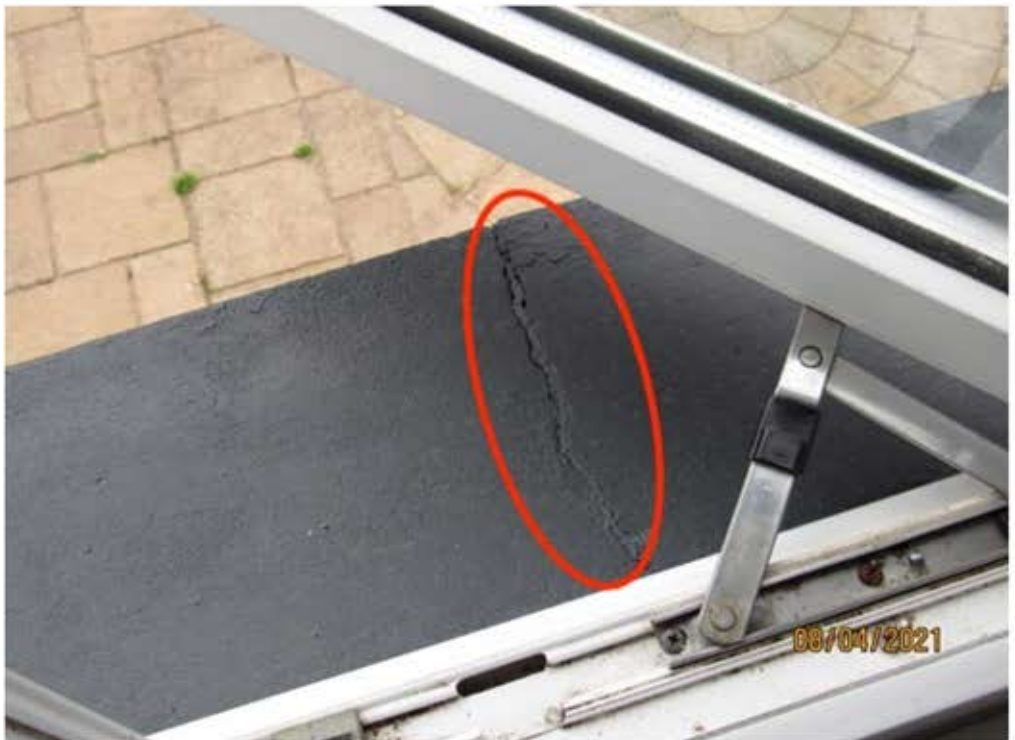
Cracking in bedroom 3 window sill

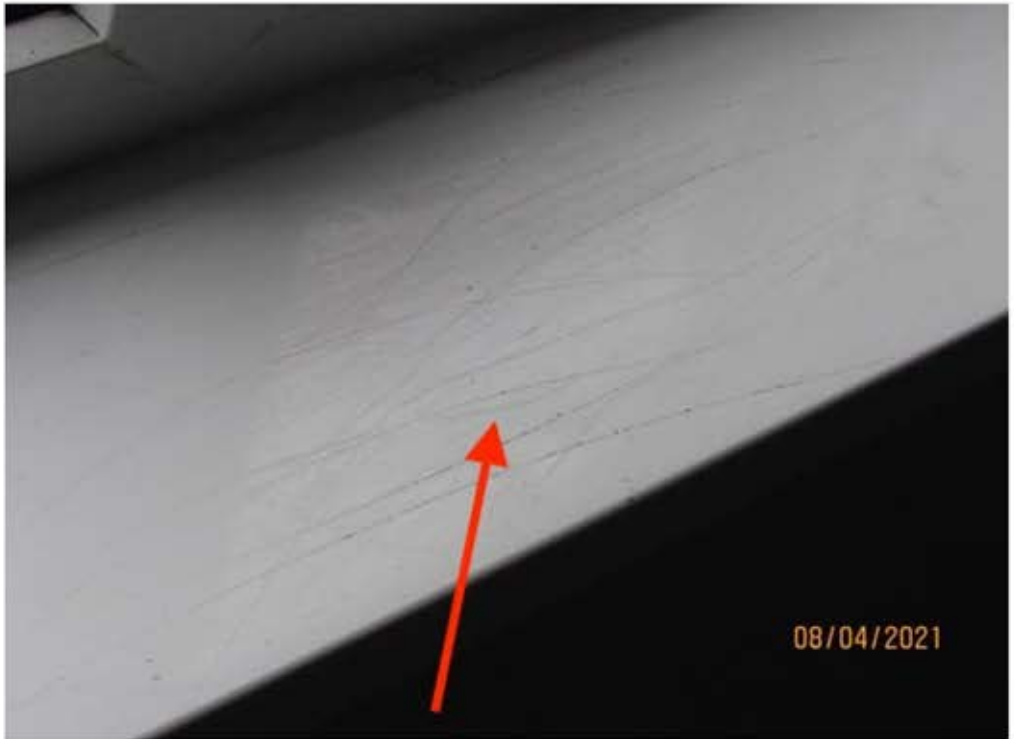
Scratches in window sill

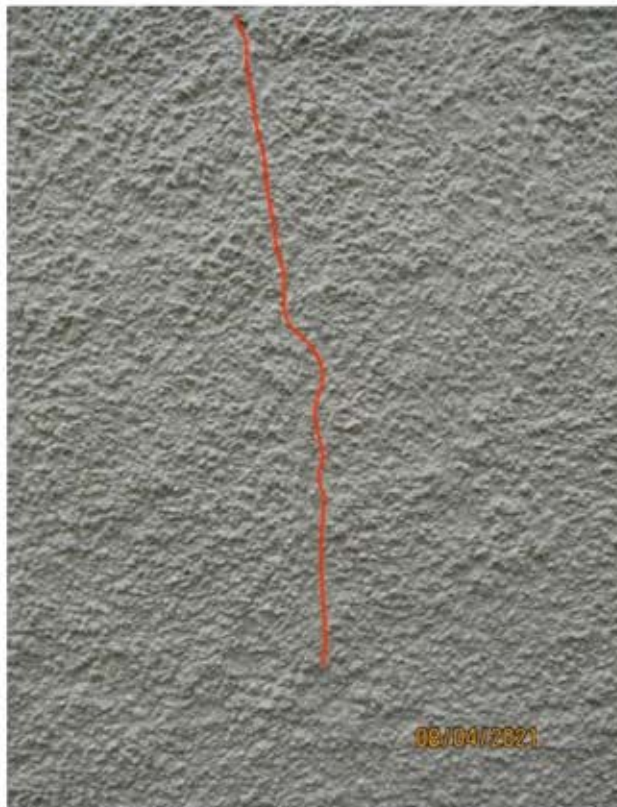
Fine cracking in render on east wall

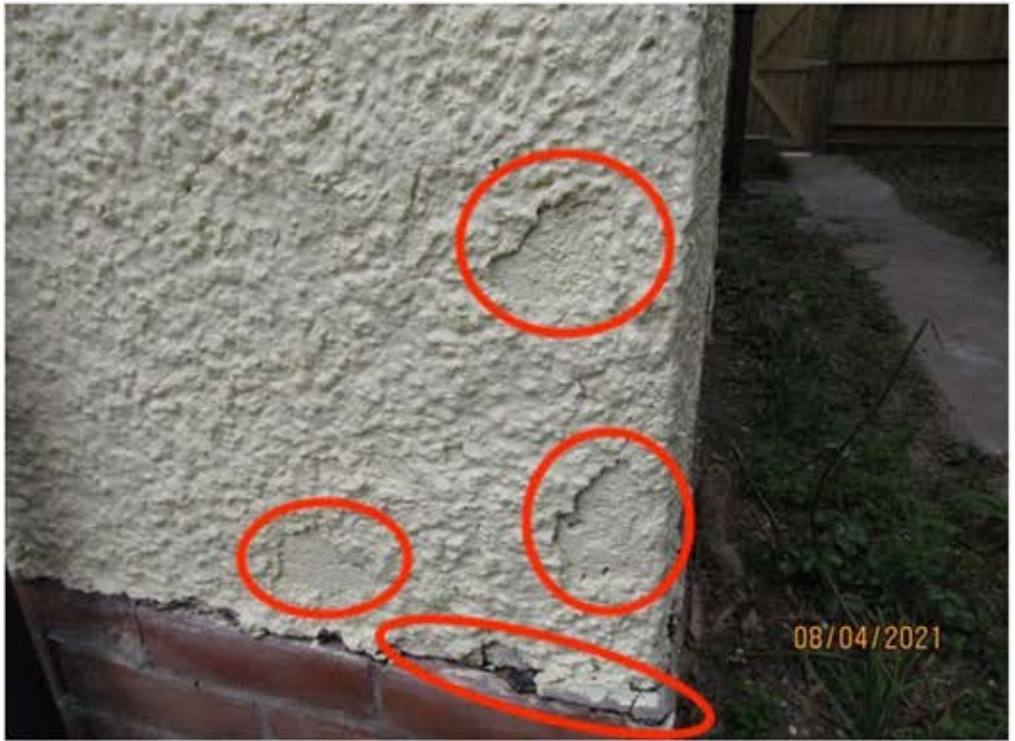
Poor application of render at south-east corner

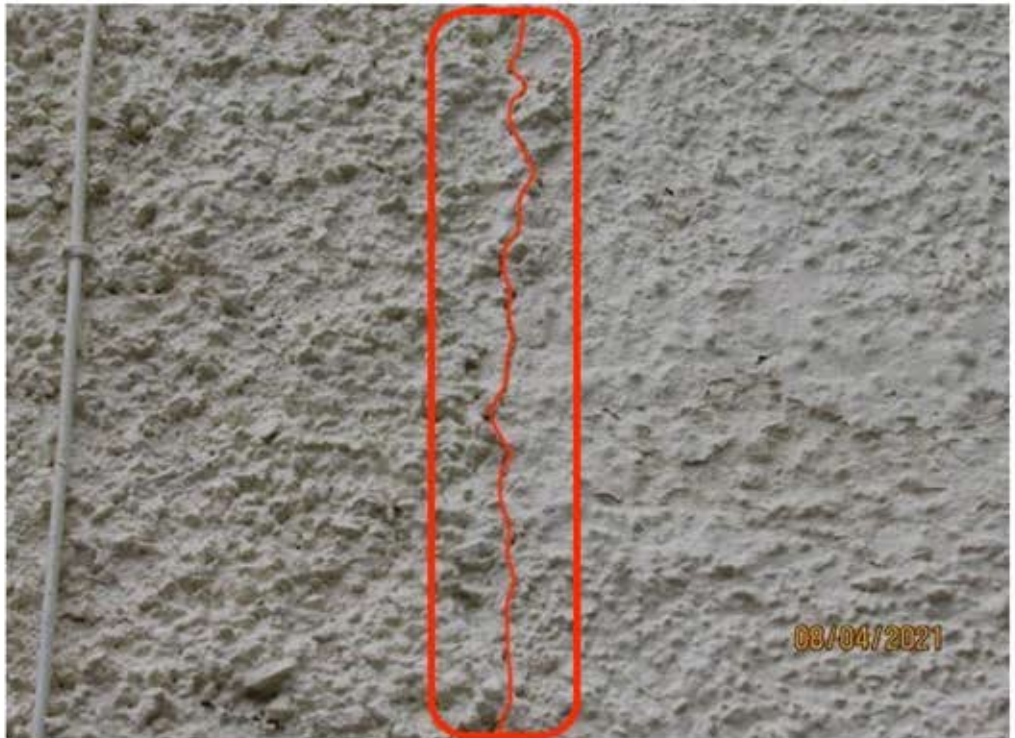
Fine cracking between render types on west wall

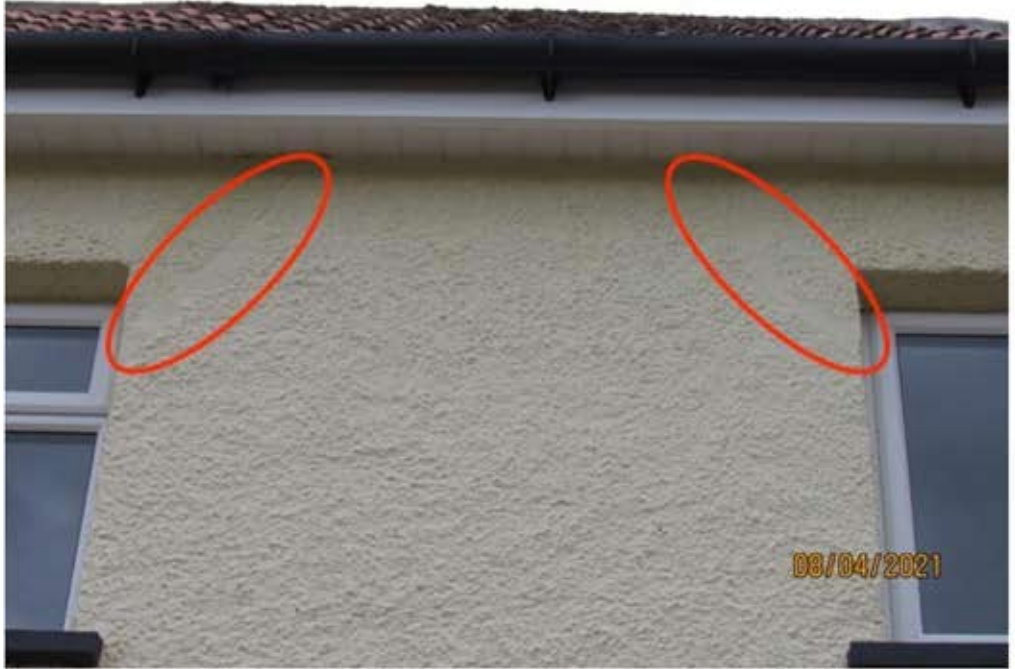
Areas of repair above windows on south wall

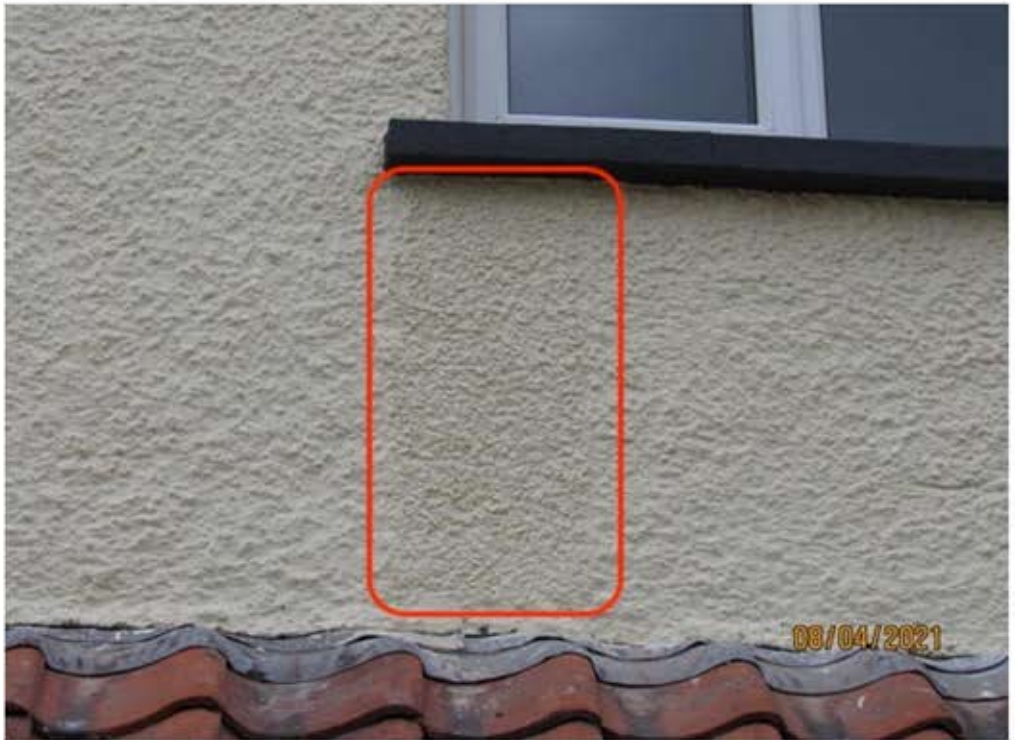
Example of different render used for repair work

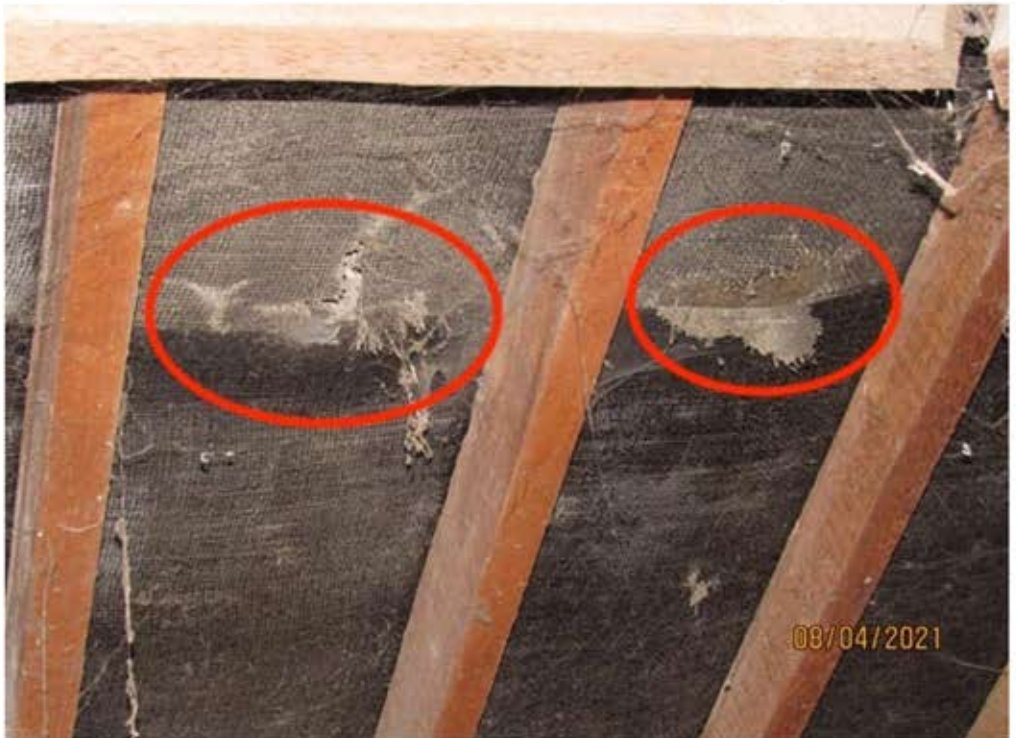
Example of poor condition of bitumen felt underlay

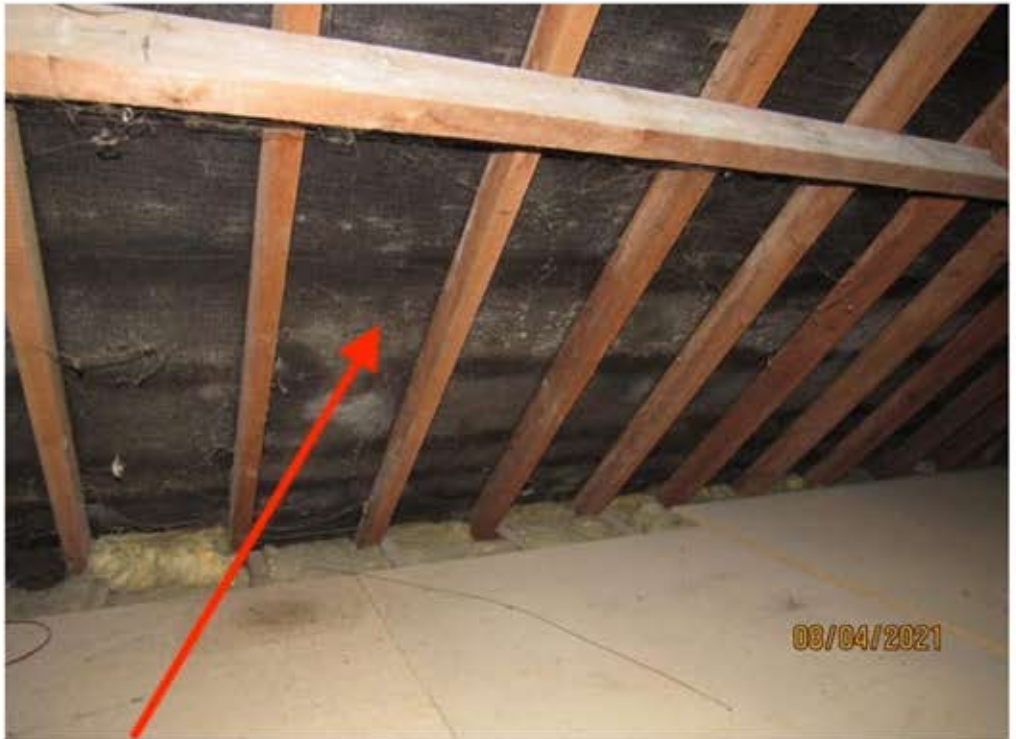
Water staining on underlay

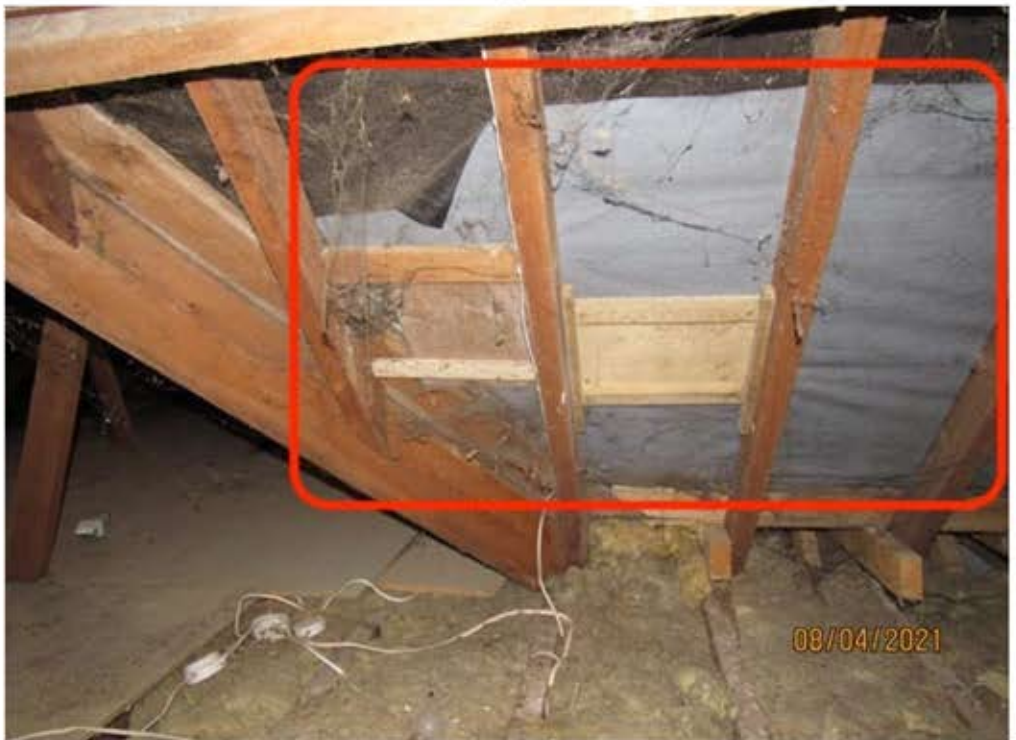
Patch repairs to east central slope
