**Mi BUILDING SURVEY**

# BUILDING SURVEY REPORT

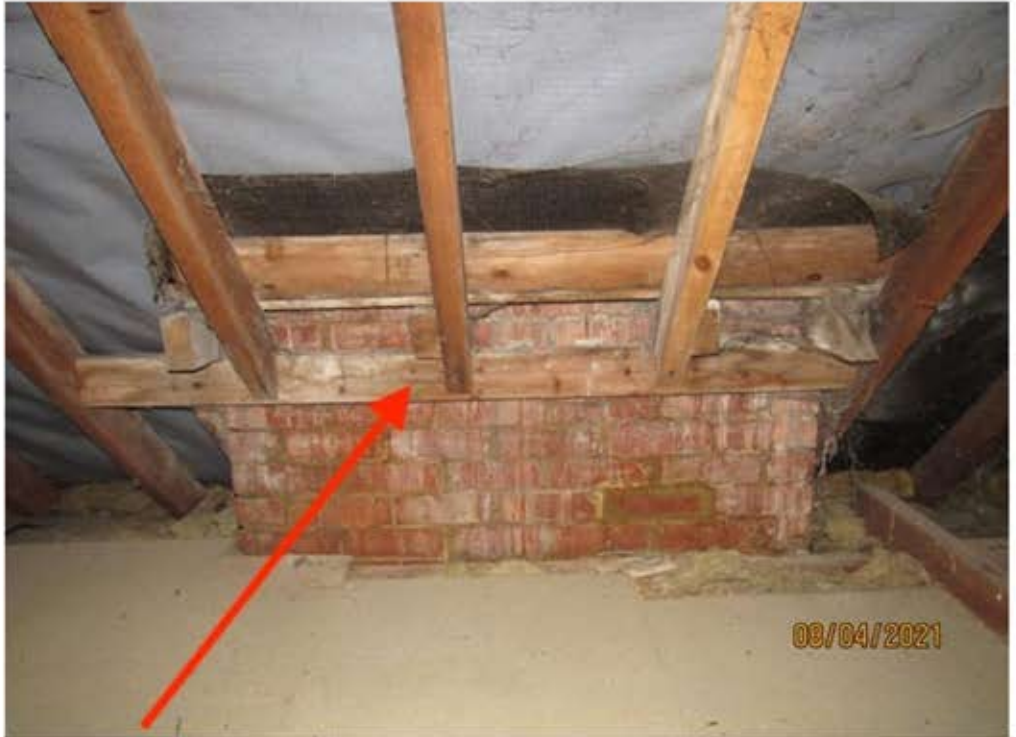
Water staining and high moisture meter readings in both chimney stacks

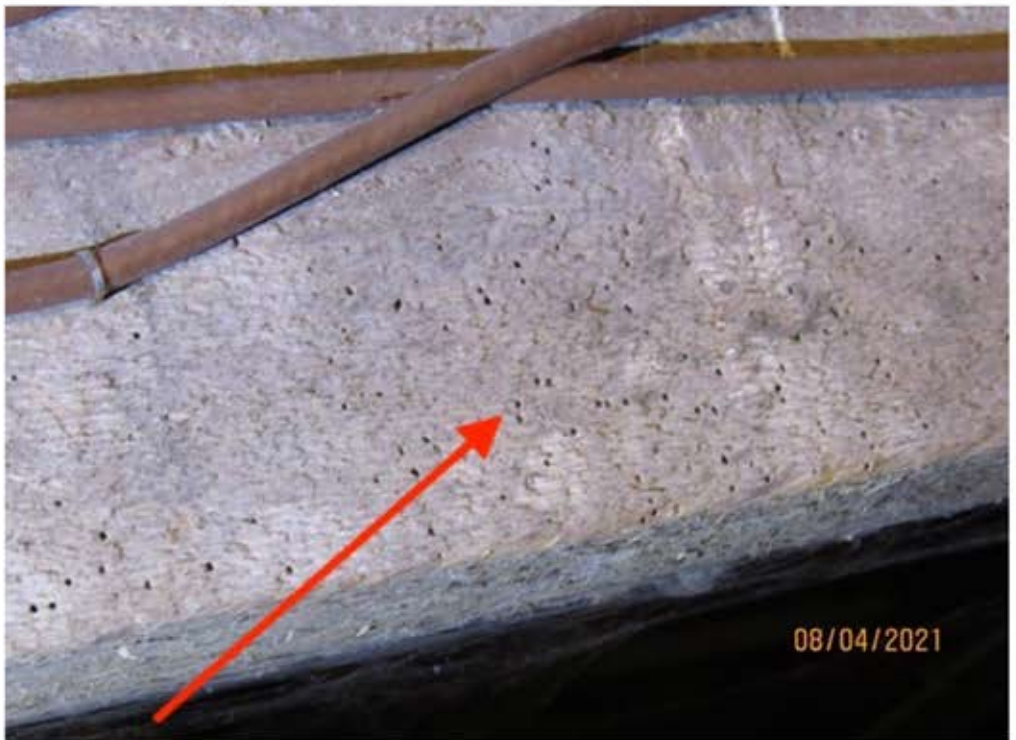
Wood boring insect activity in purlin near access hatch

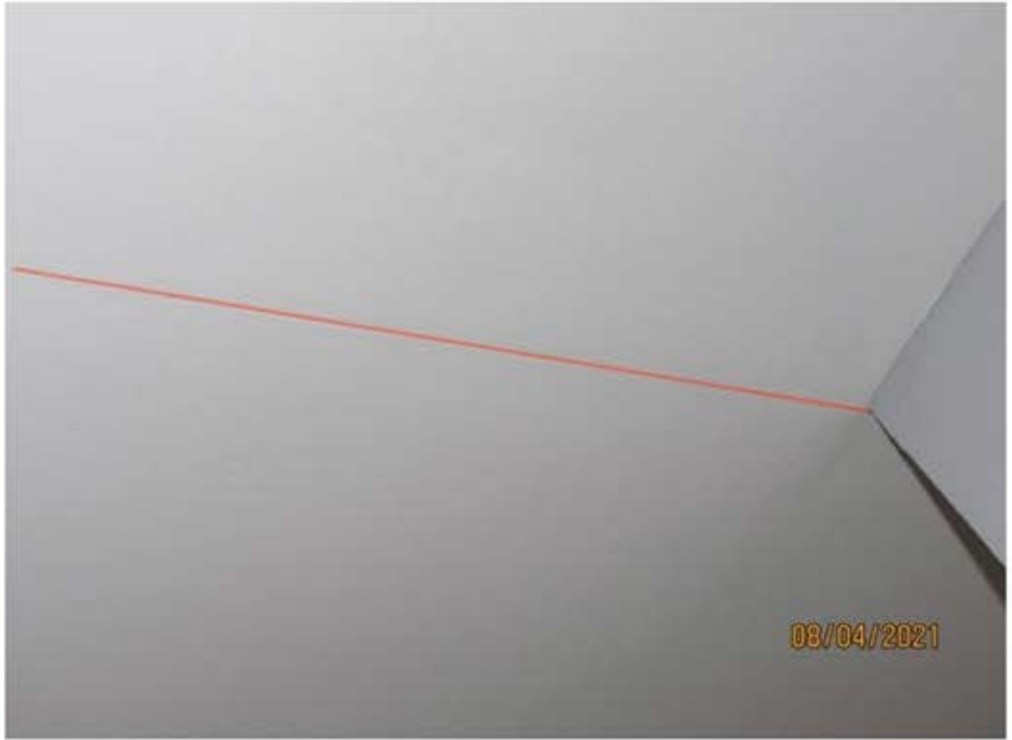
Fine cracking in bedroom 1

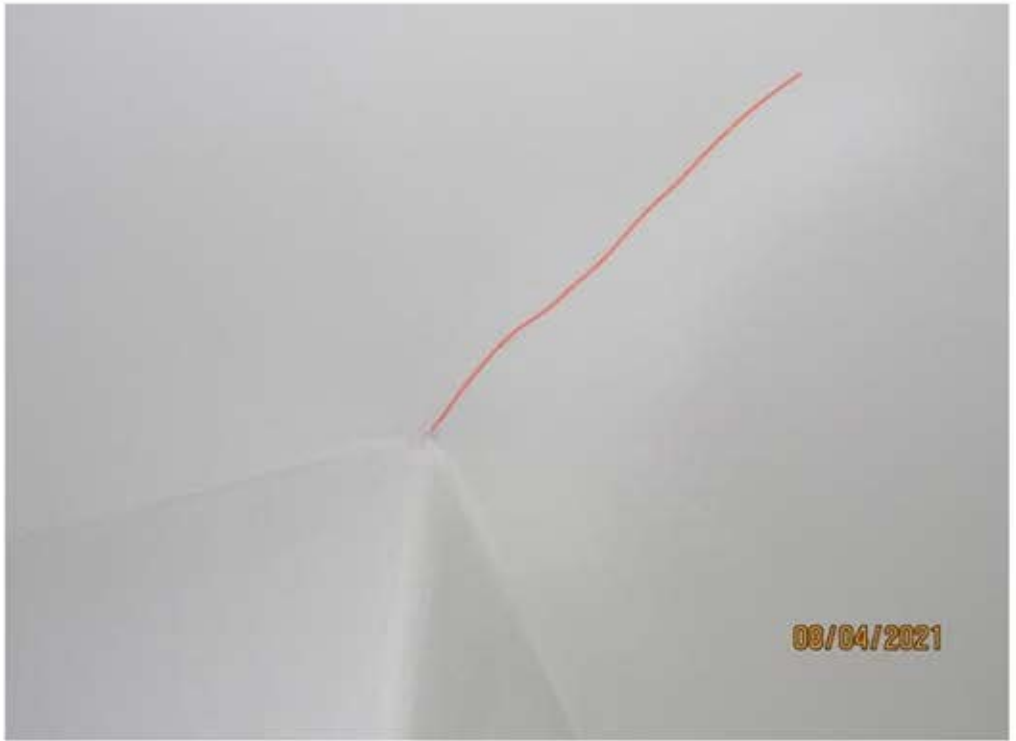
Fine cracking in dining room

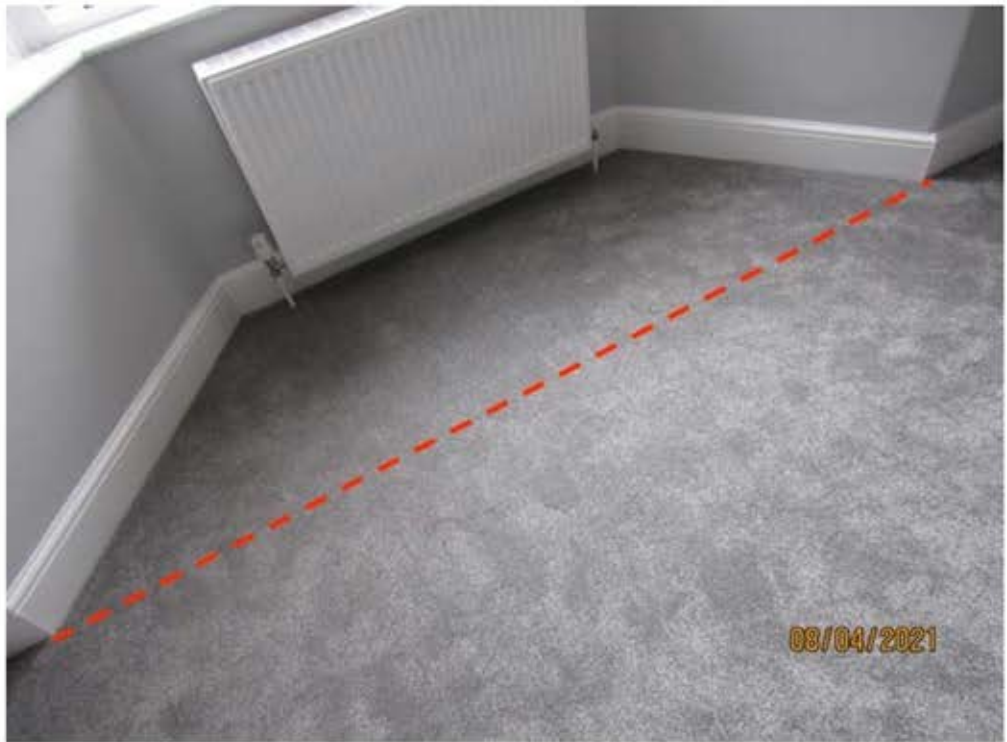
Floors of bay windows are timber

5. If damp is found below the bay window floors and as a precaution, suitable air-bricks should be installed in the east and west walls below both bay windows, to create cross ventilation. Ensure that the air bricks, are kept clear to maintain adequate ventilation in the underfloor void. External paving and soil levels should not be allowed to rise above the level of the air bricks. A lack of ventilation can allow moisture levels beneath the floor to become elevated, increasing the risk of the development of moisture related defects such as rot and infestations by wood boring insects.

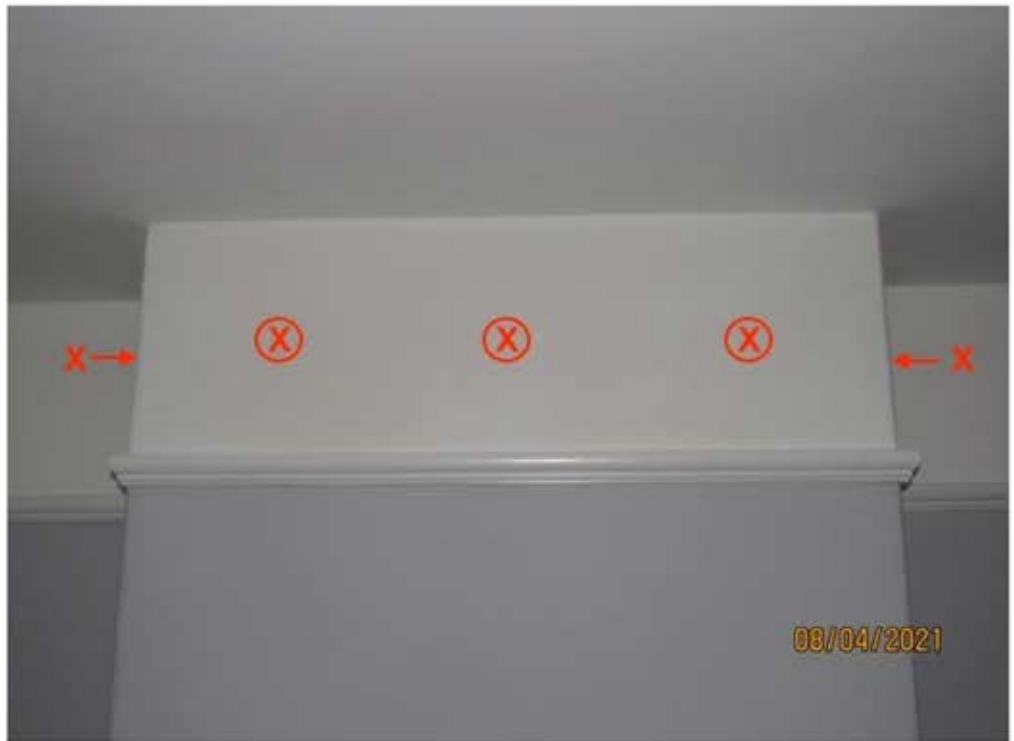
Moisture meter readings in bedroom 2 (High = red X within red circle. Above average = red X)

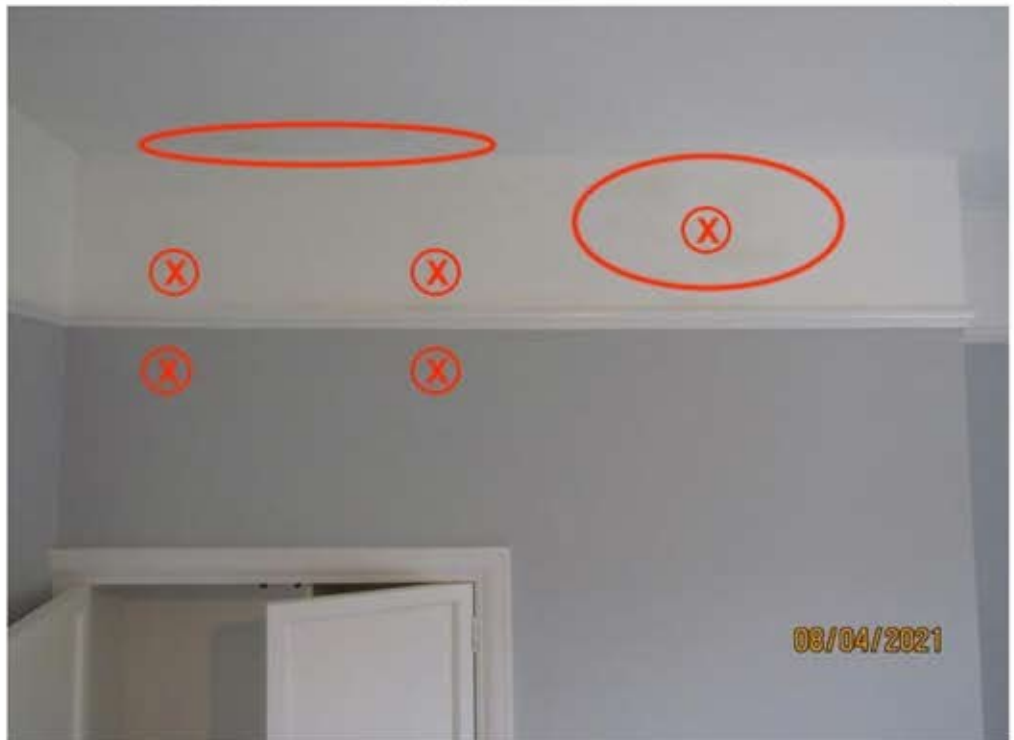
Moisture meter readings in bedroom 3 and areas of water staining

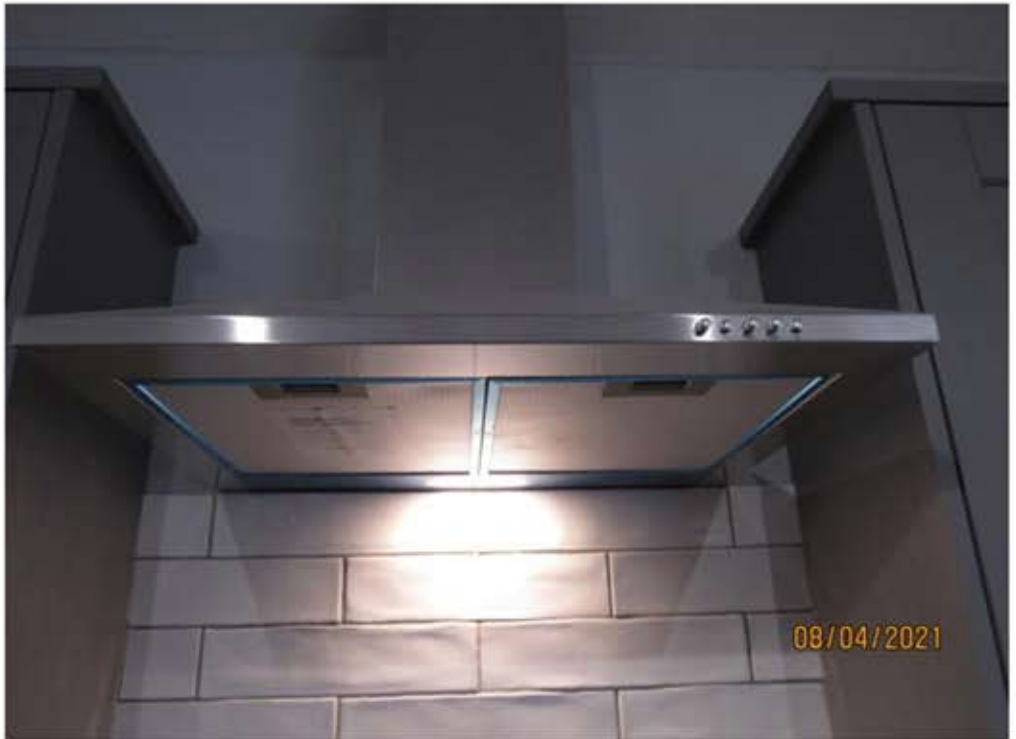
Kitchen hob extractor hood

<p><b>Action Required</b></p>	<ol style="list-style-type: none"> <li>1. It is recommended that you connect the kitchen hob extractor fan to an external vent grille in the east wall to improve the ventilation of warm, damp air generated.</li> <li>2. It is recommended that you install an extractor fan in the utility which is connected to an external vent grille in the north wall to improve the ventilation of warm, damp air generated.</li> <li>3. If you intend on using the AGA, it must be serviced and recommissioned by an AGA registered engineer and then ongoing servicing must be undertaken.</li> <li>4. If the AGA is reconnected to use either oil, gas or dual fuels, a carbon monoxide alarm must be installed in the kitchen. See section 6.6 Other Services.</li> <li>5. Maintain, repair or replace units as necessary.</li> </ol>

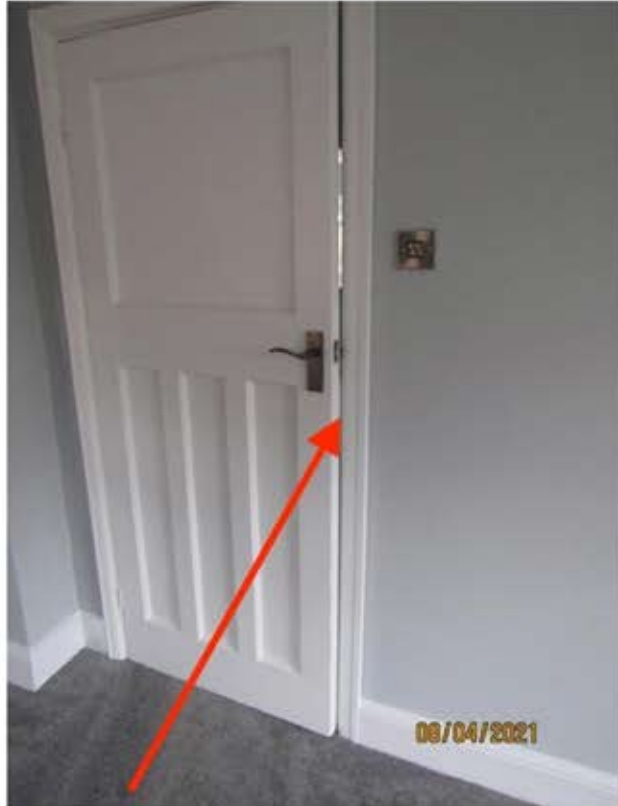
Doors for bedrooms 2 and 3 do not close correctly

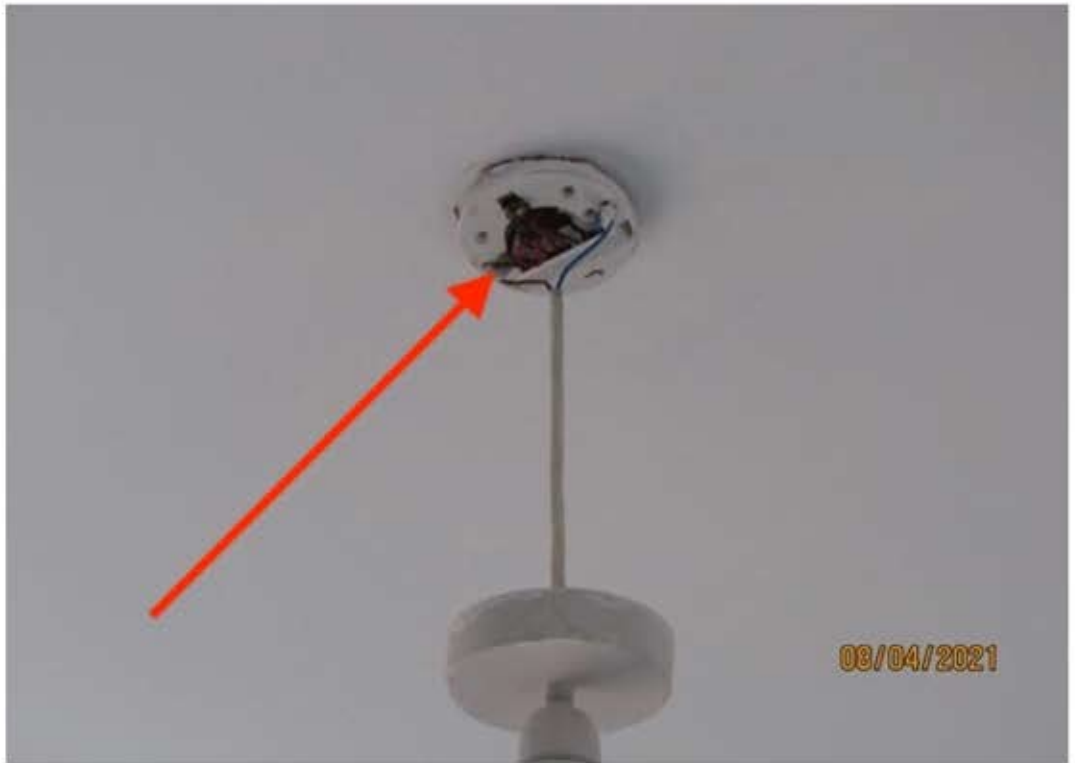
Exposed wiring in bedroom 4 ceiling pendant fitting

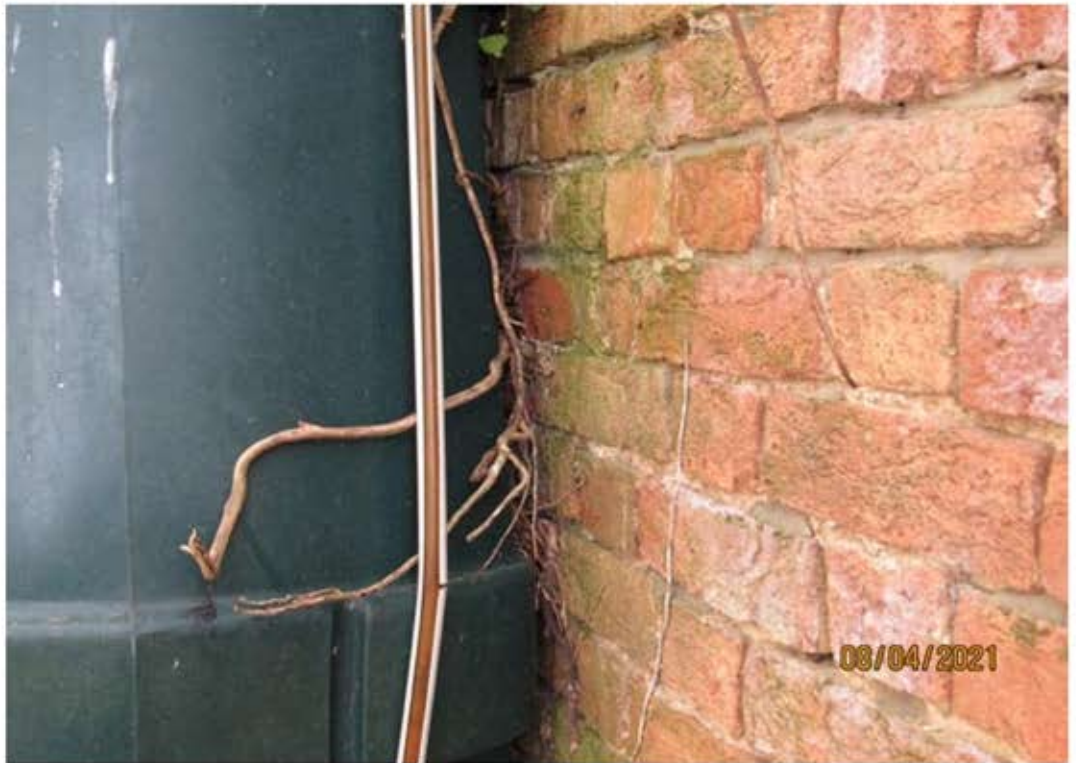
Oil storage tank touching west boundary wall

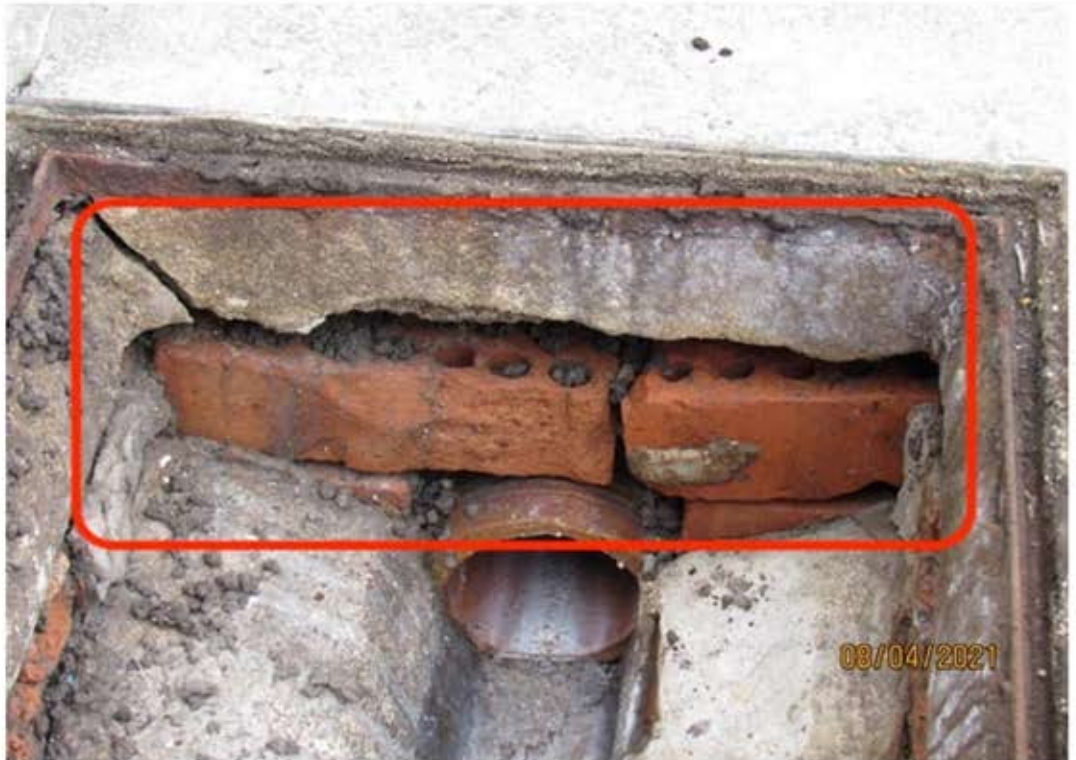
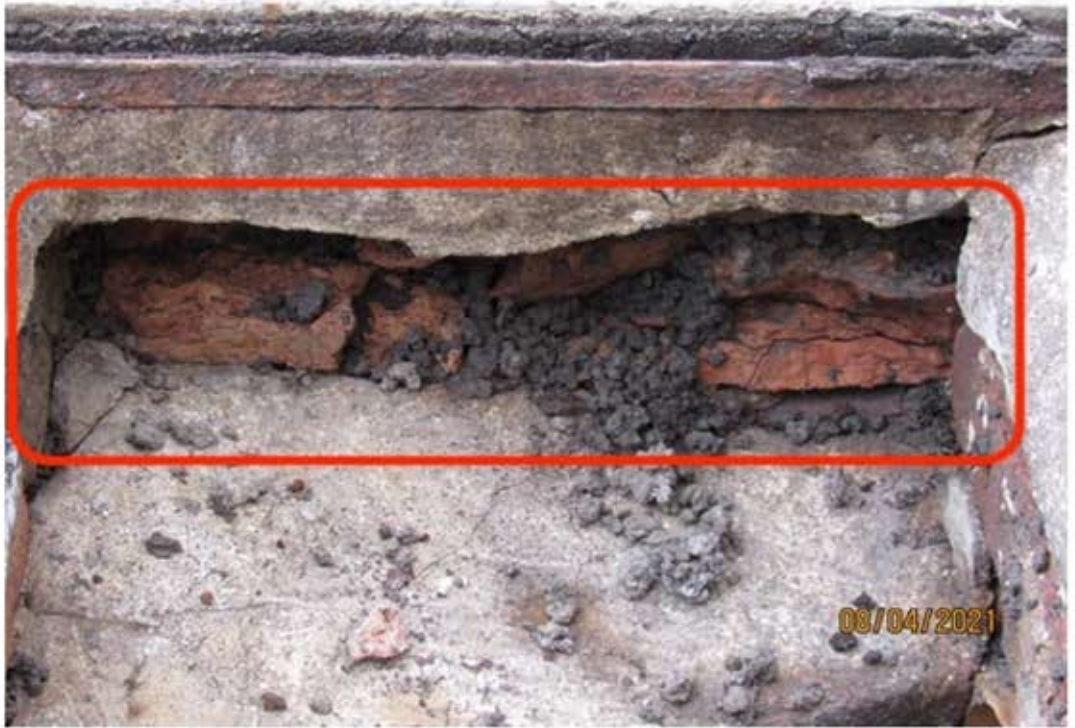
Poor condition of brick chamber wall in IC 1

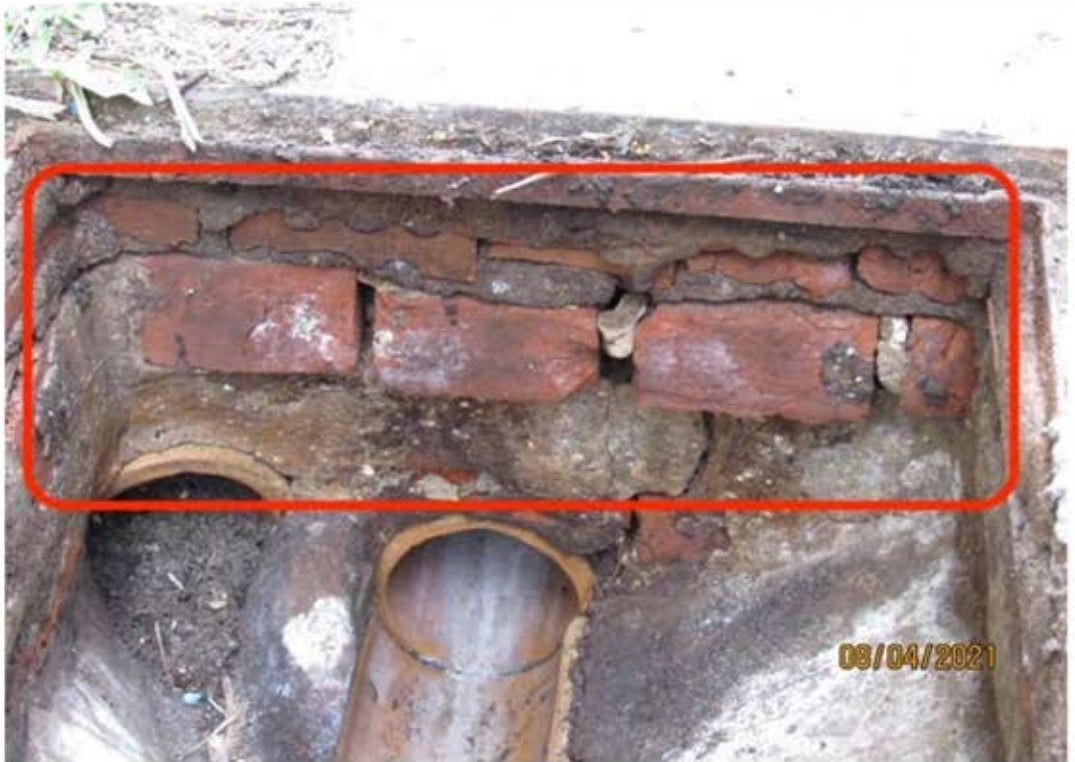
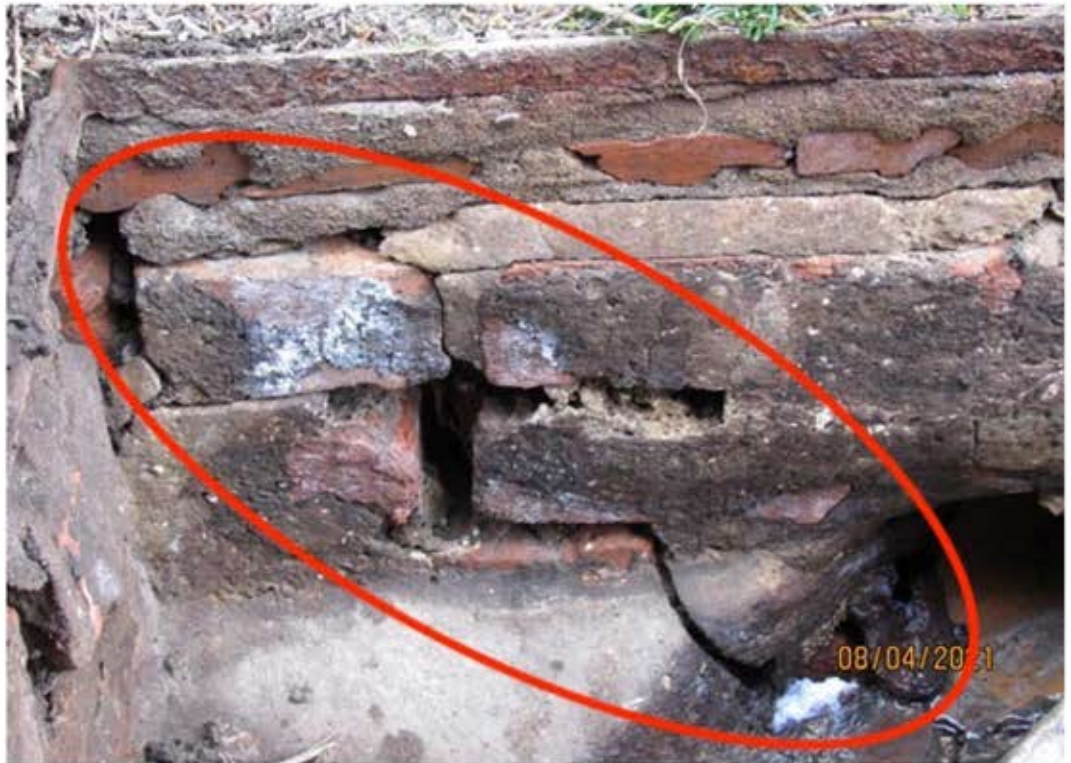
Poor condition of brick chamber wall in IC 2

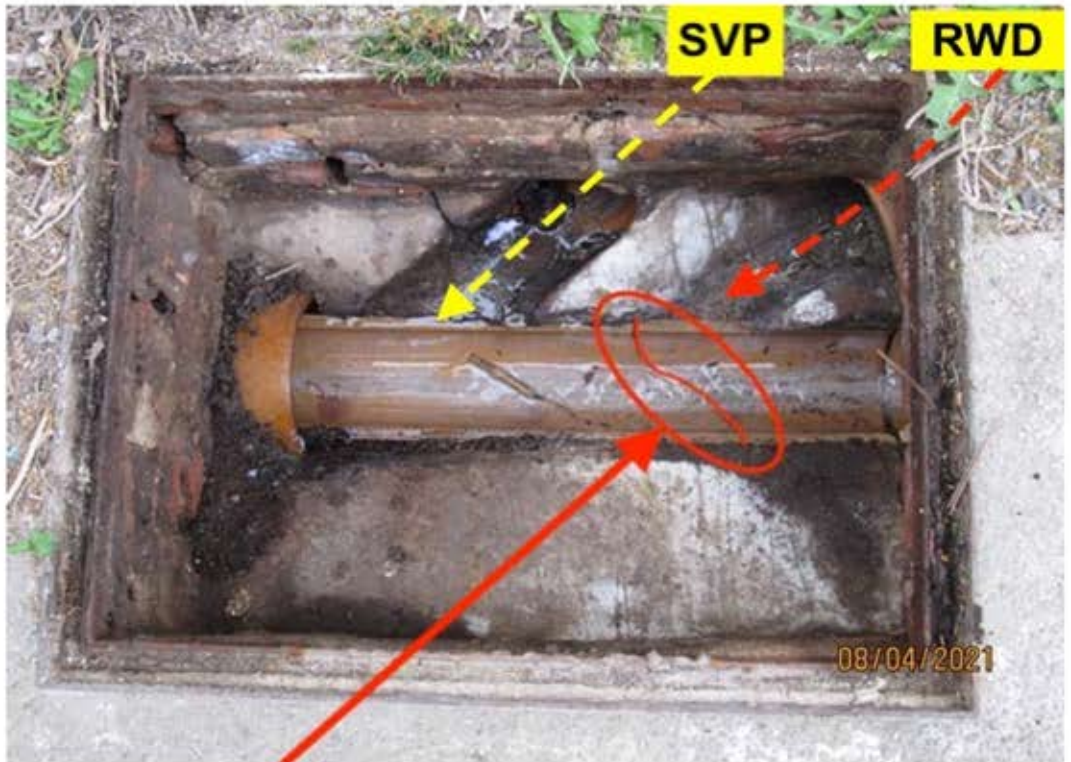
IC 2 - Cracking in pipe, SVP flow direction and possible flow from Rainwater Downpipe (RWD)

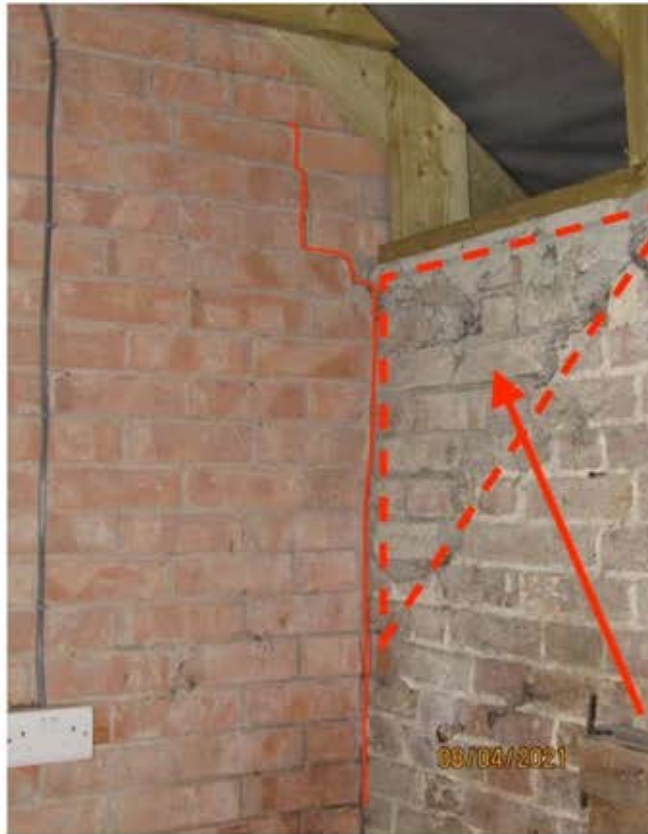
Cracking in partition wall between garage and workshop and area of rebuilt north wall

1. All loose or missing mortar around brickwork should be repointed.
2. Any fine cracking should be raked out and repointed.
3. All walls should be examined regularly to inspect for changes in the nature of the cracking or other defects that may become apparent. If the cracking widens or more cracking appears, you should commission a structural engineer to assess the ability of the walls to carry the load of the roof.
4. The north boundary wall will require ongoing monitoring for signs of further movement.
5. A new gutter end should be fitted.
6. Repair or replace any defective tiles or other parts as required.
7. Have the electrics tested by the electrician.
8. Normal maintenance is required.

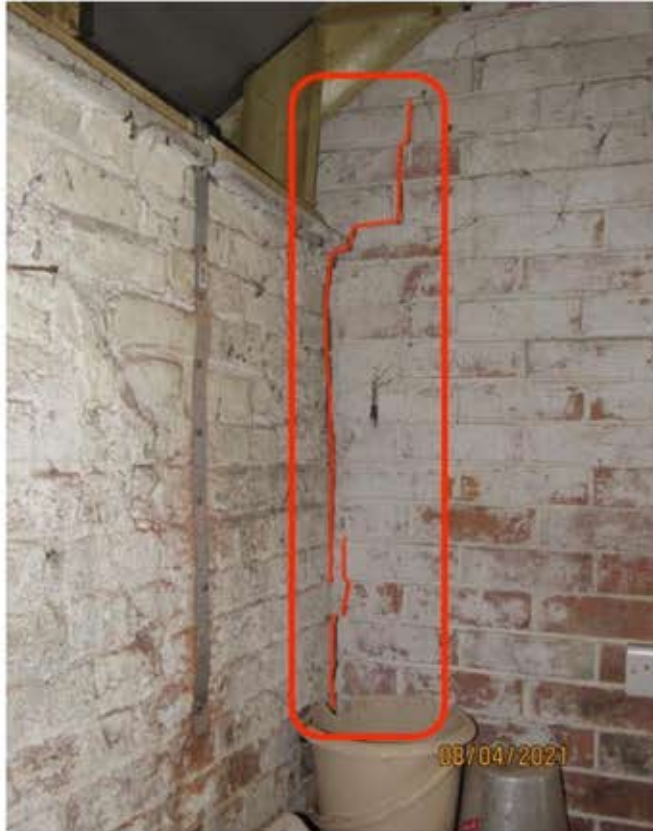
Cracking in partition wall between workshop and garage

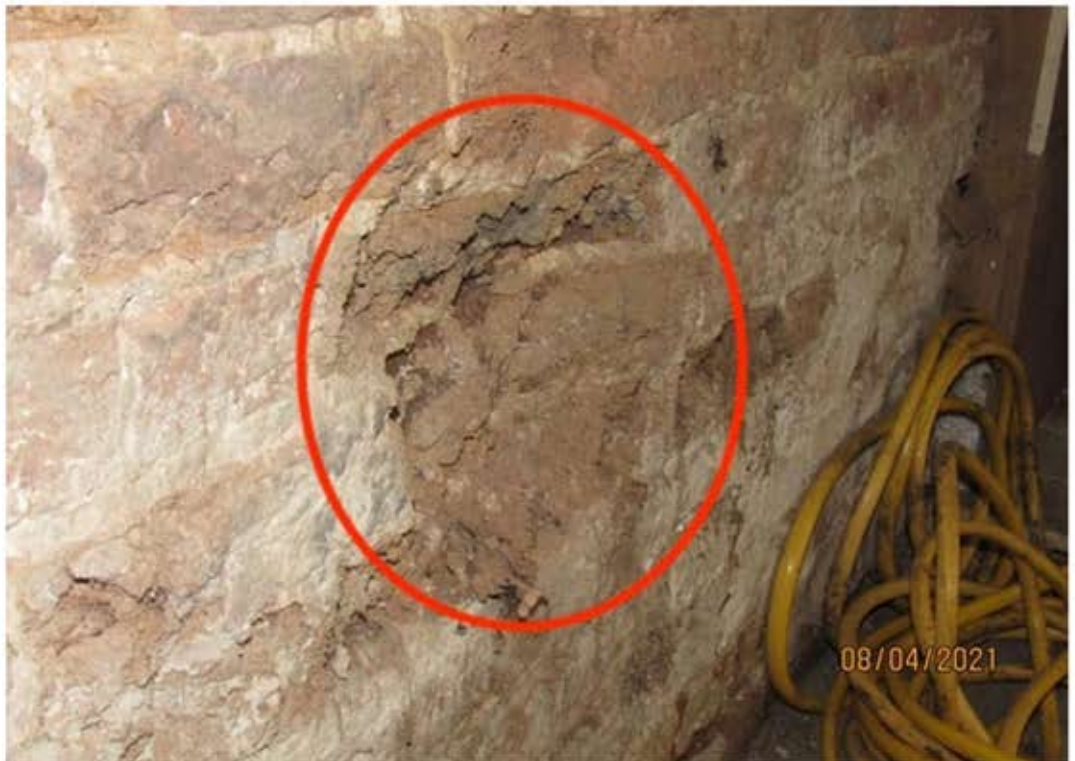
Spalled brickwork on inside surface of workshop north wall

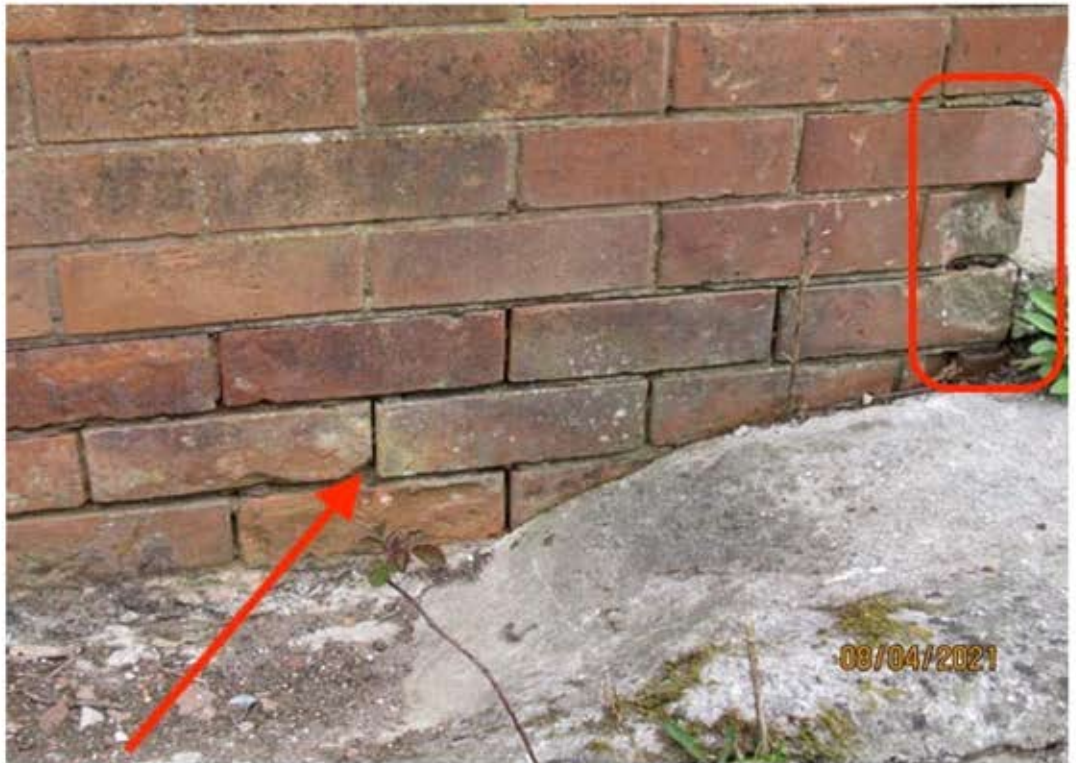
Missing mortar near south-west corner of workshop

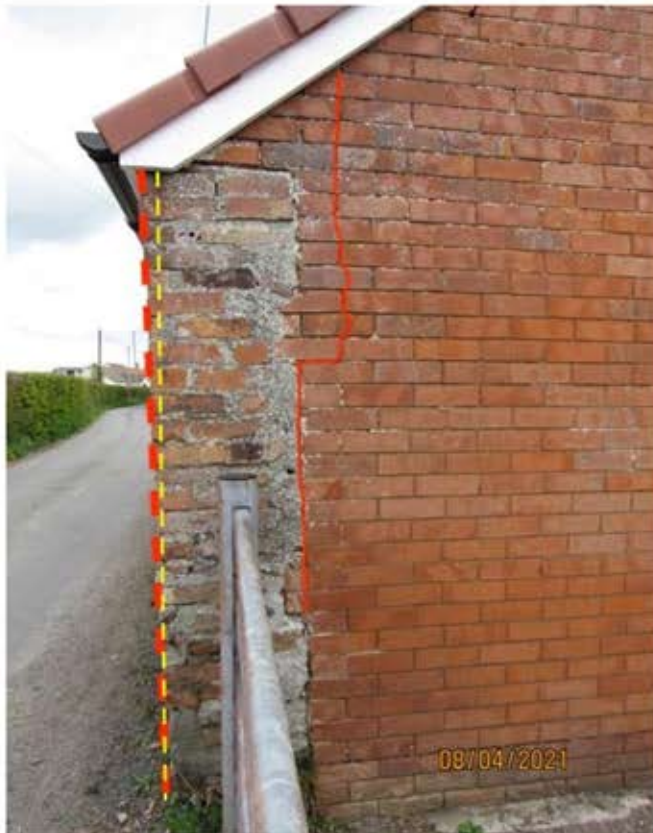
Cracking near north-west corner of workshop and north wall out of plumb

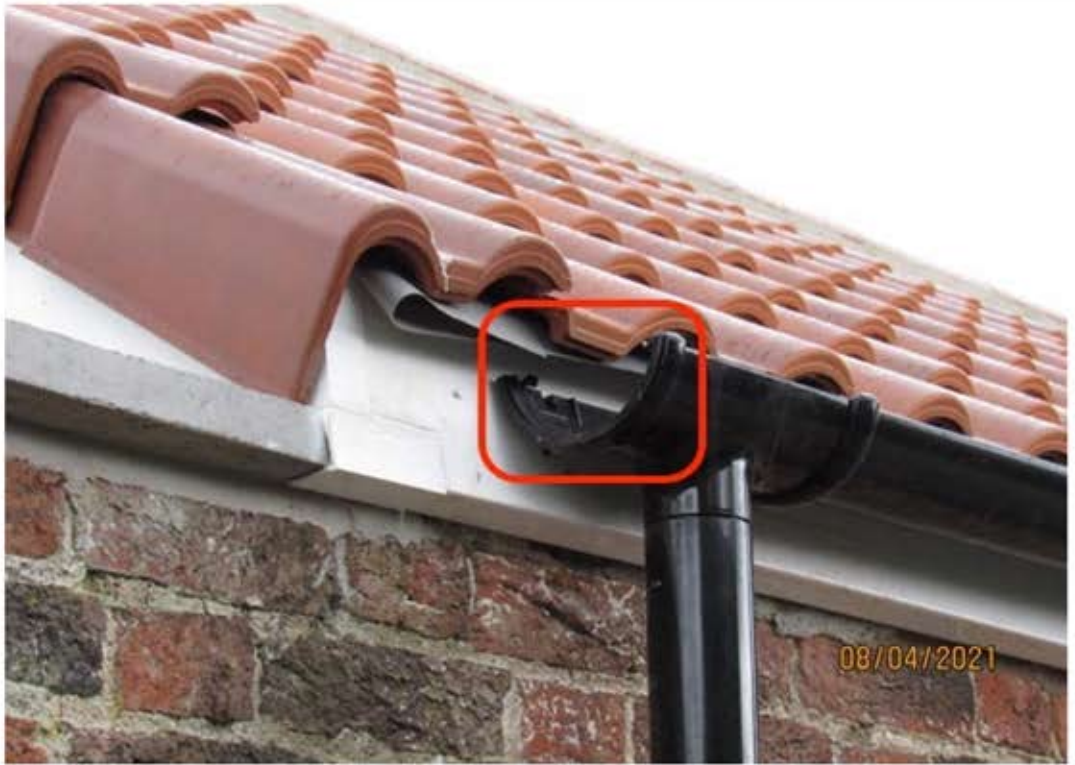
Missing gutter end cap on north-east corner of garage

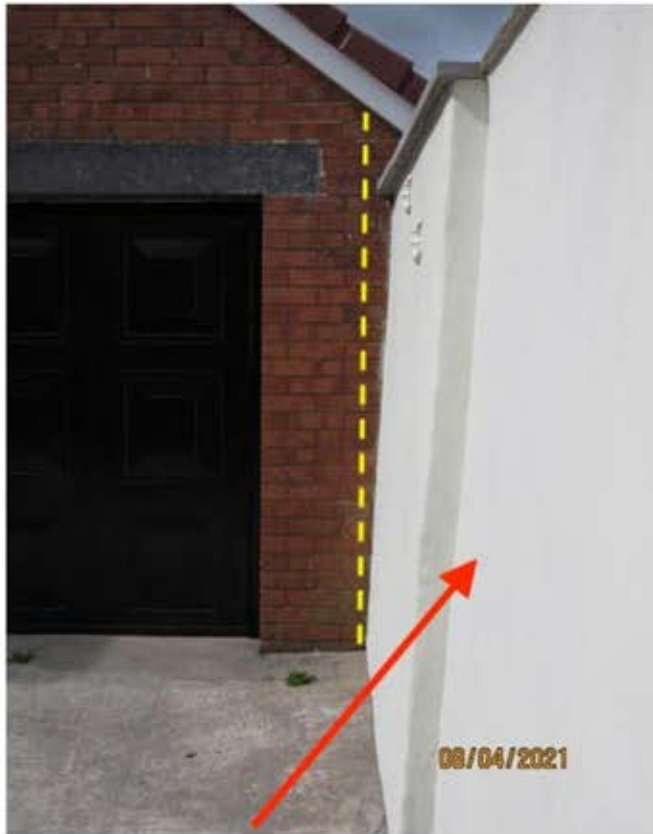
The rendered north boundary wall is leaning towards the road.

1. All boundary walls should be examined regularly to inspect for changes in the nature of the cracking or other defects that may become apparent.
2. The yew tree, and in fact all trees within the boundaries, will need to be carefully managed so that they do not grow too large. Trees close to the property should not be cut down as this will cause the ground where the tree stood to rise up or 'heave'. This action can cause significant damage to foundations and walls of properties which is why careful tree management is required.  
For further information: <https://www.trees.org.uk/Find-a-professional>
3. The boundary fencing will regular timber preservative treatment. Any damaged or missing fencing will need replacing.
4. You should ask your legal adviser to check on any indications of ownership and responsibilities for maintenance for the boundaries included in the title documents.

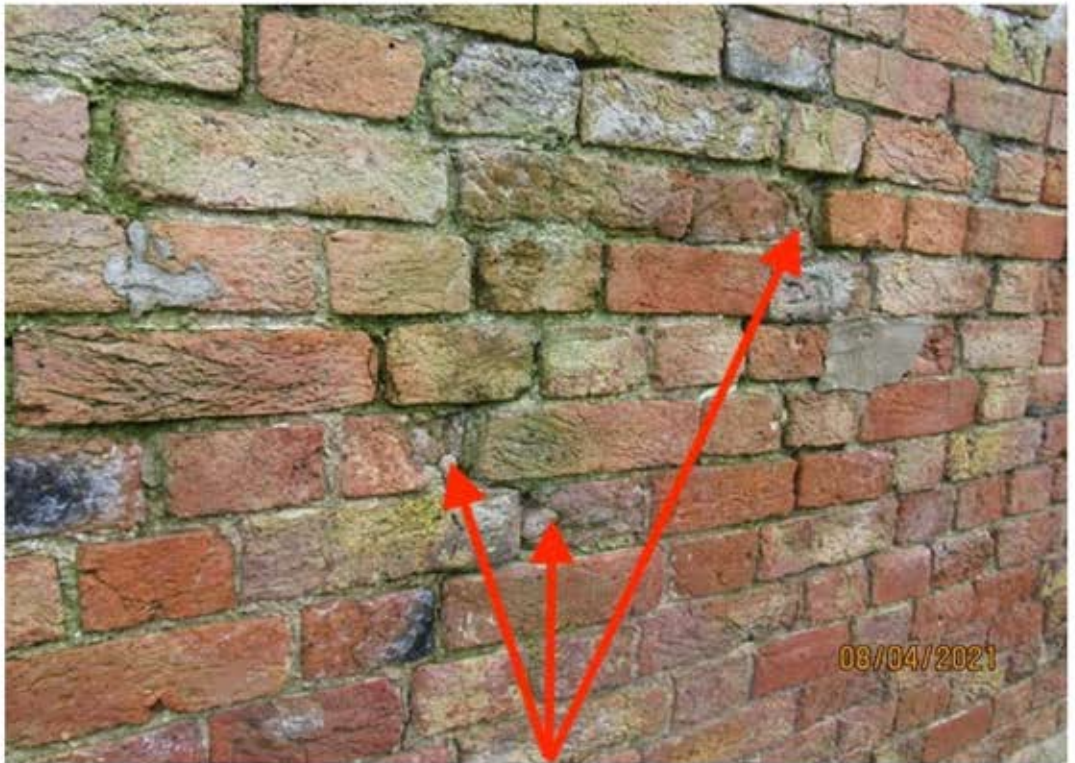
Poor condition of north boundary wall

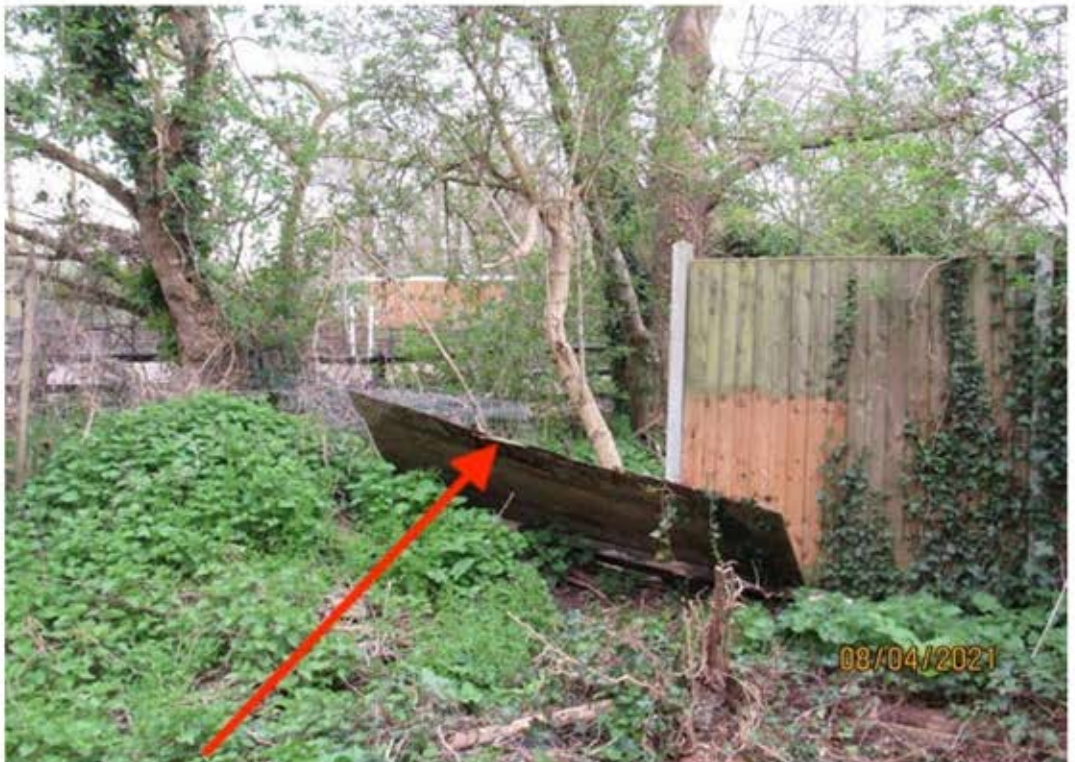
Fallen section of fencing near south-west corner

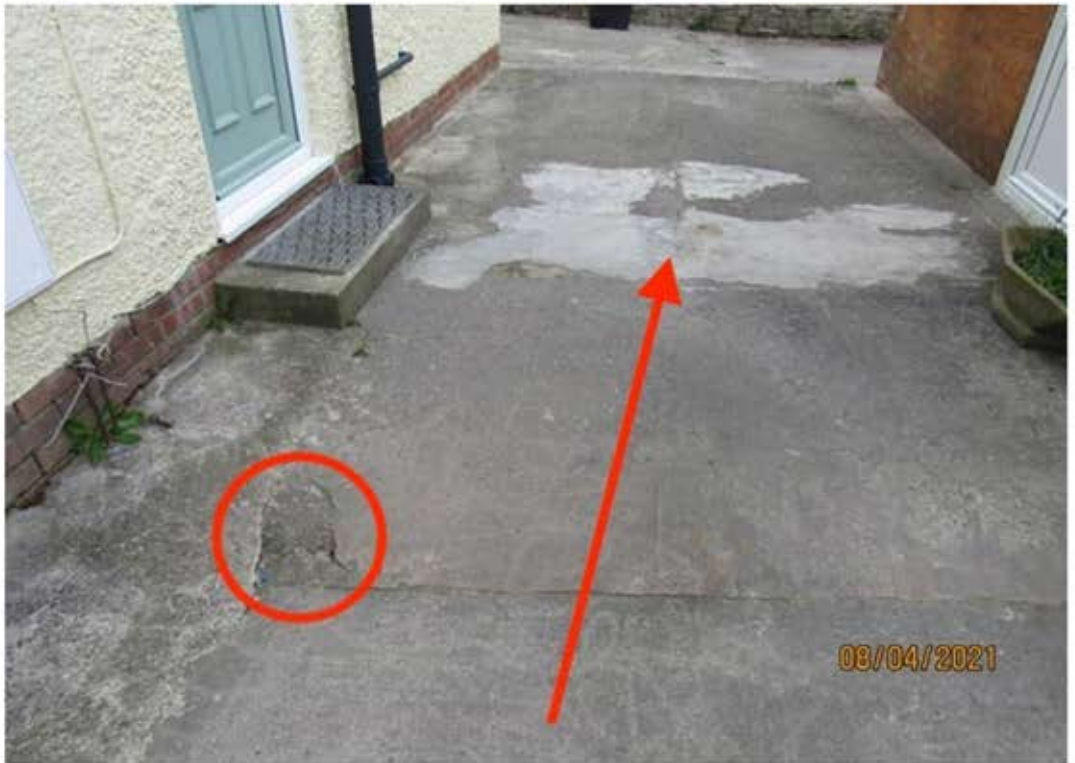
Area of broken surface and patch repairs to driveway
