**Mi BUILDING SURVEY**

# BUILDING SURVEY REPORT

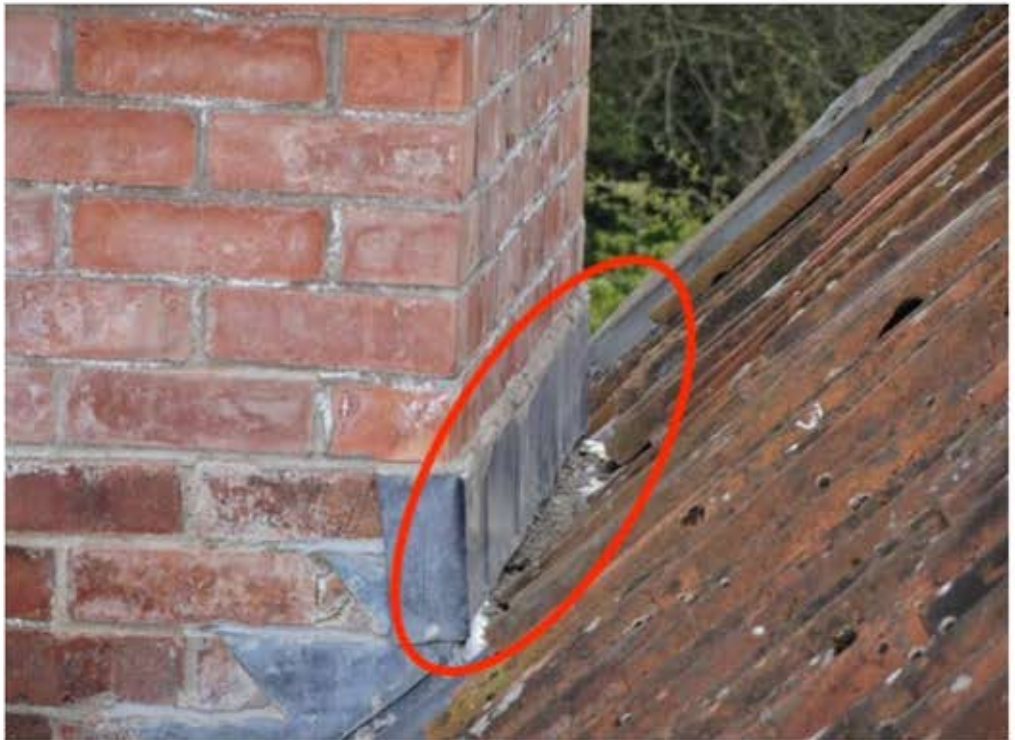
Vulnerable rear gutter on chimney stacks

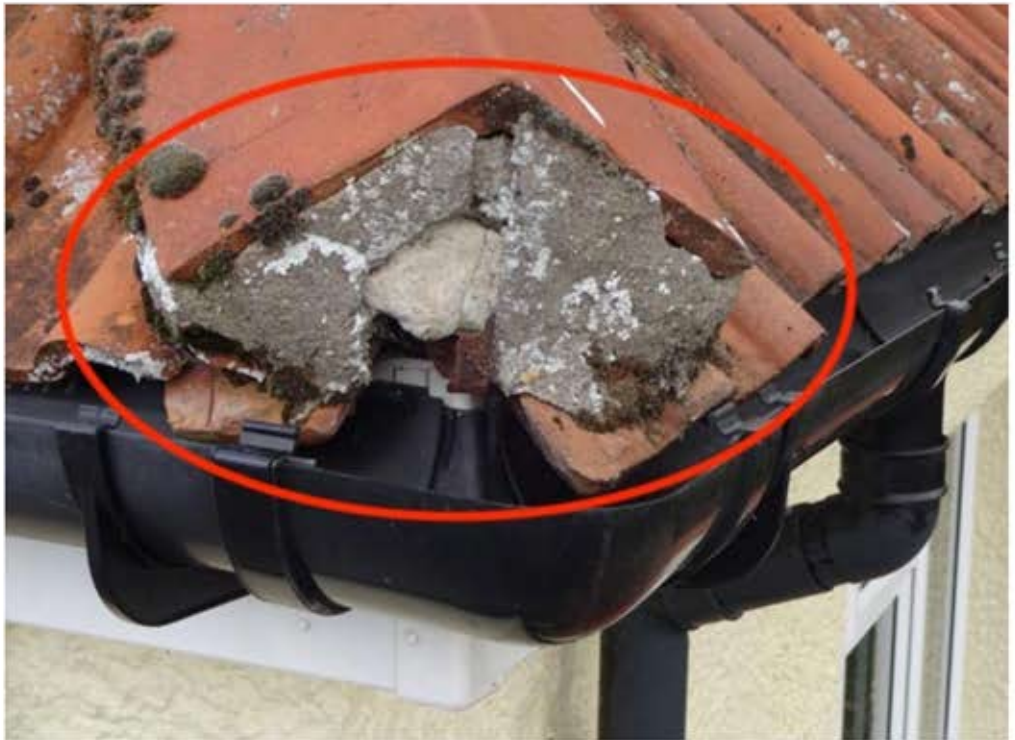
Poor workmanship at south-west corner

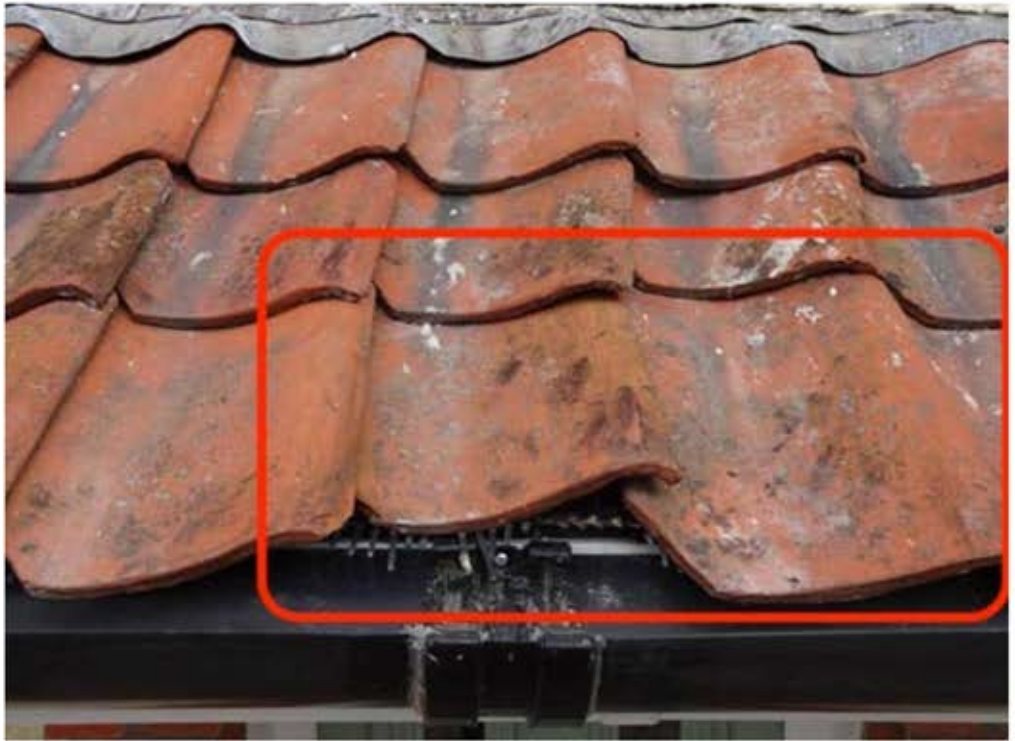
Poor fixing of bay roof tiles

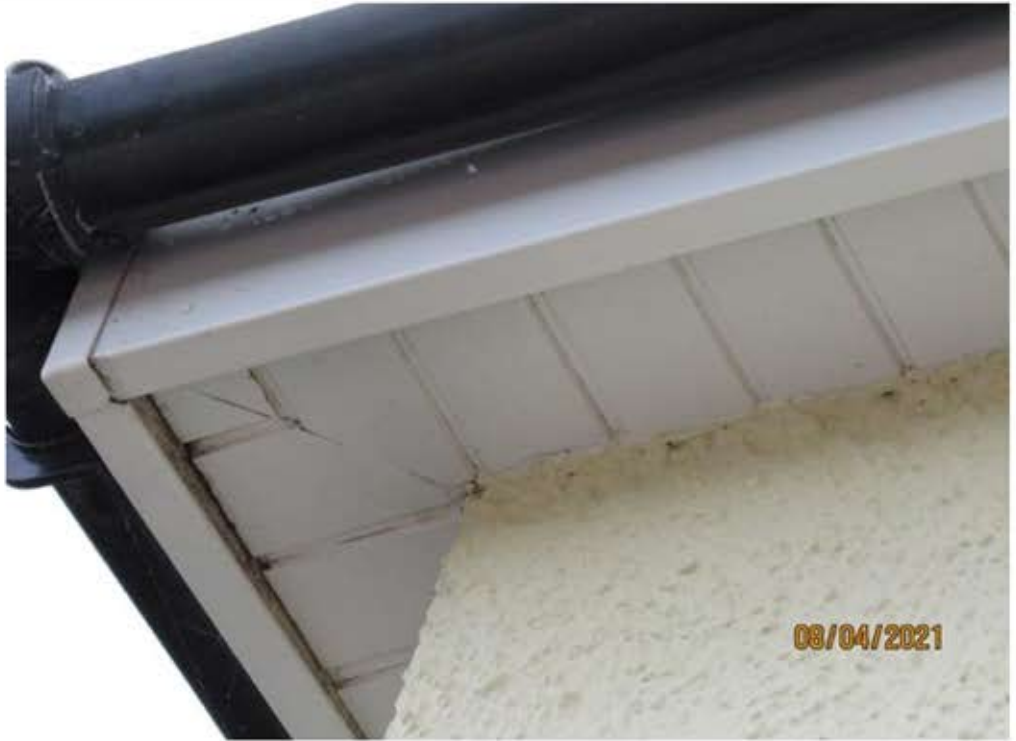
uPVC fascia and soffit boards but with no ventilation

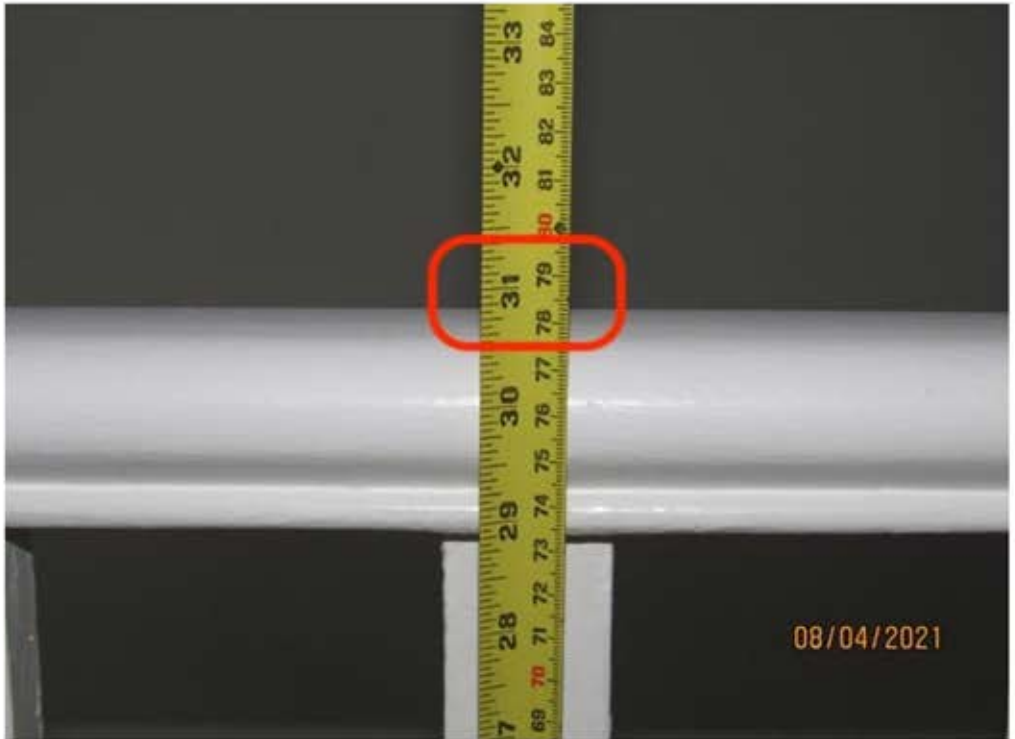
Height of handrail on landing bannister is too low

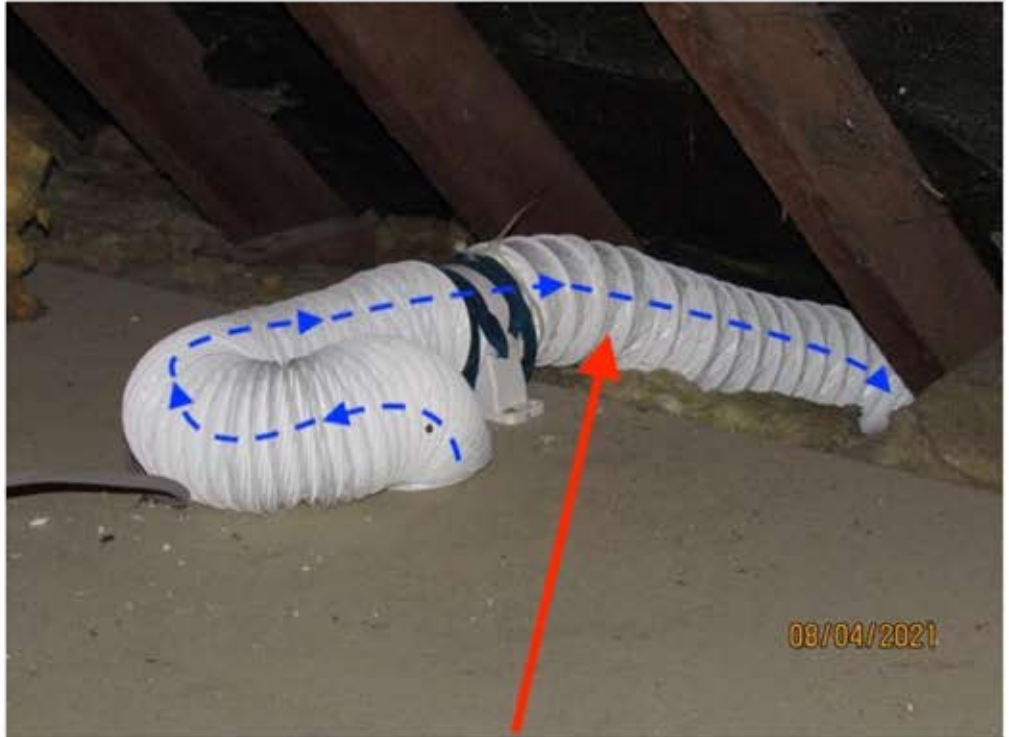
Flexible ventilation ducting from bathroom extractor fan to external vent grille in east soffit board

<p><b>Action Required</b></p>	<ol style="list-style-type: none"> <li>1. Improve the routes of extracted air from the bathroom and ensuite to reduce the risk of damp issues in the roof space as mentioned above.</li> <li>2. All extractor fans should be kept operational as they reduce the levels of moisture within the rooms and the risk of condensation damage to the walls and ceiling.</li> <li>3. Regular maintenance of all seals to the showers is required to prevent water displacement.</li> </ol>

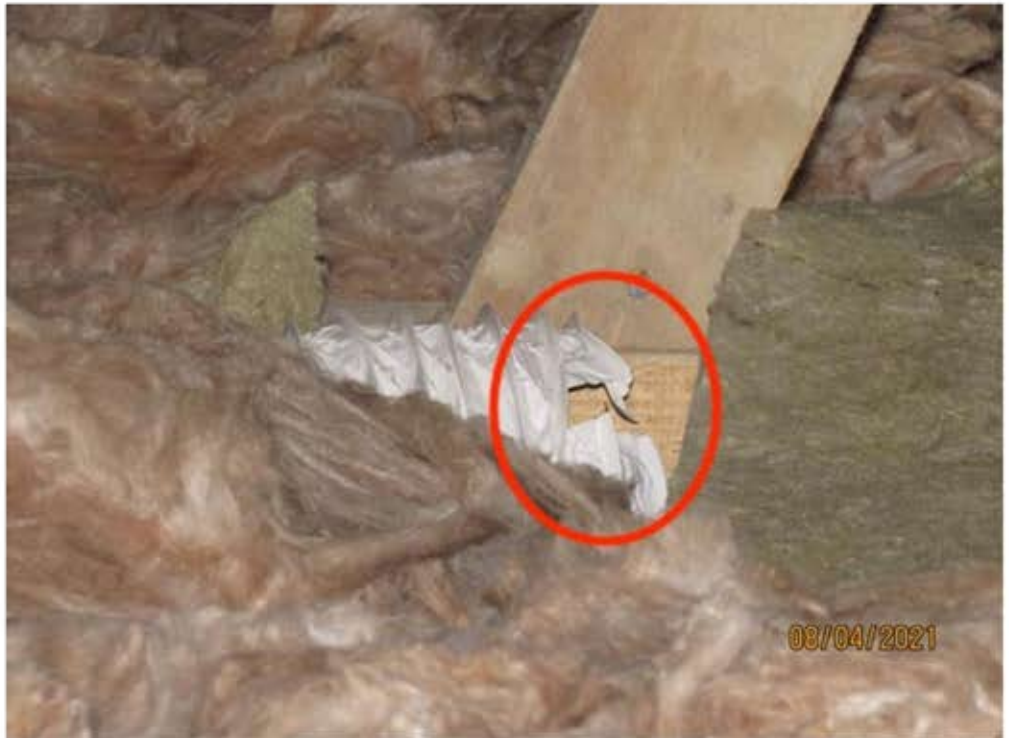
Part of flexible ventilation ducting from ensuite extractor fan to external vent grille in north soffit board

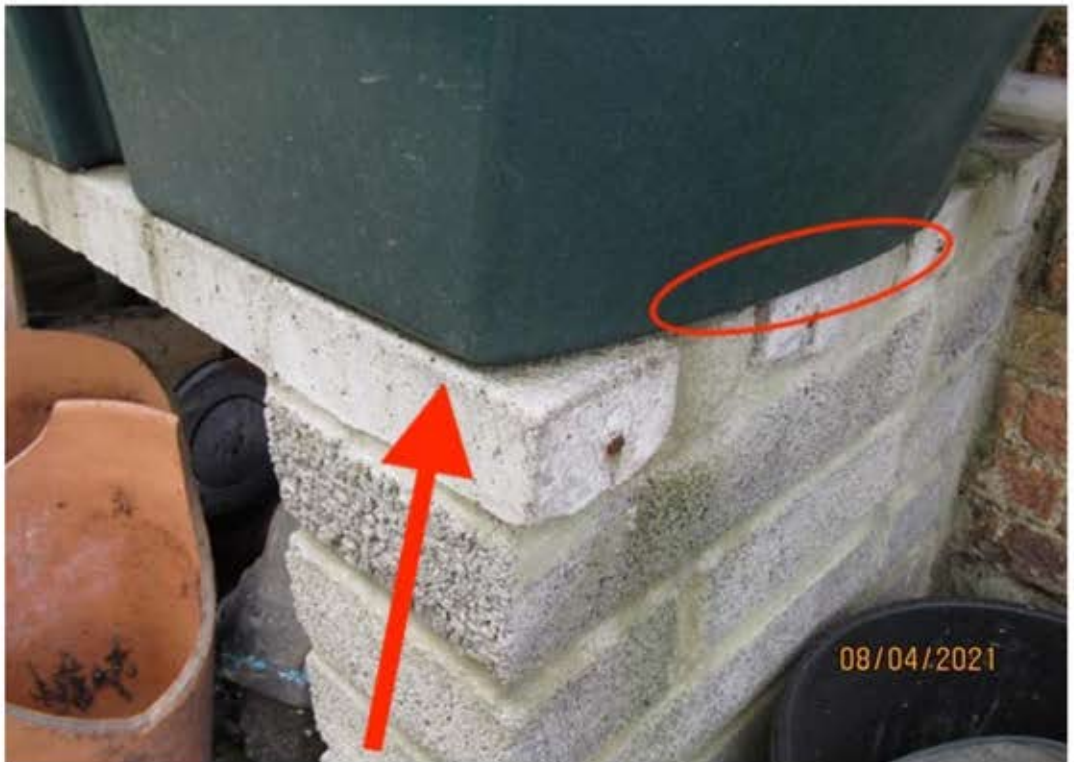
Oil tank support base is too small for size of tank

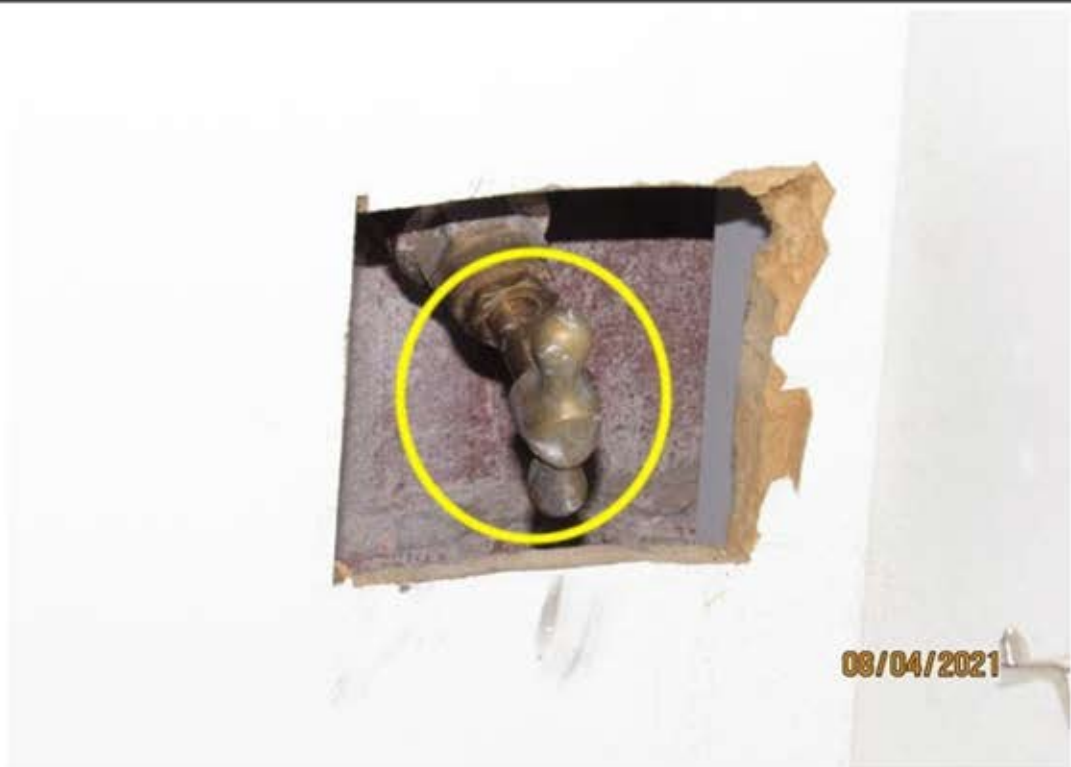
Internal water stop valve under kitchen sink

<b>Action Required</b>	<p>1. Check the installation for evidence of leaks or other defects on a regular basis i.e. approximately every 6 months, or sooner.</p> <p>Leaks most often occur at pipe joints and where pipes are subject to movement or physical damage, such as airing cupboards, roof spaces and under sinks.</p>

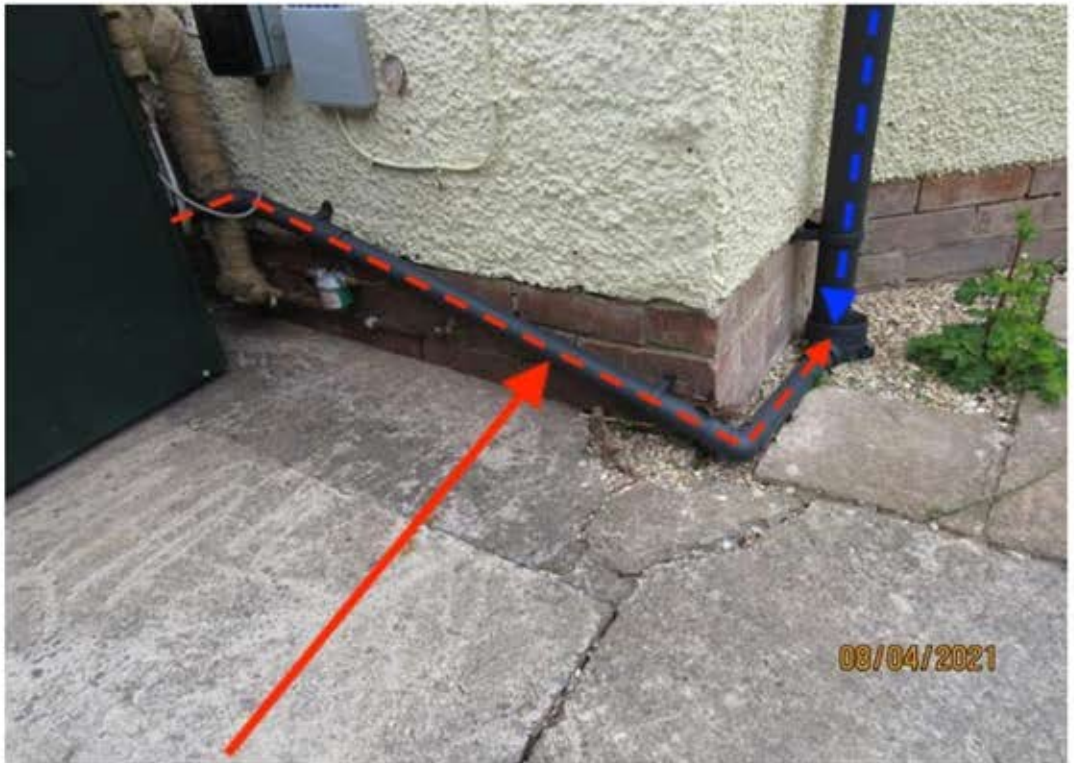
Condensate pipe sharing rainwater gully at south-west corner

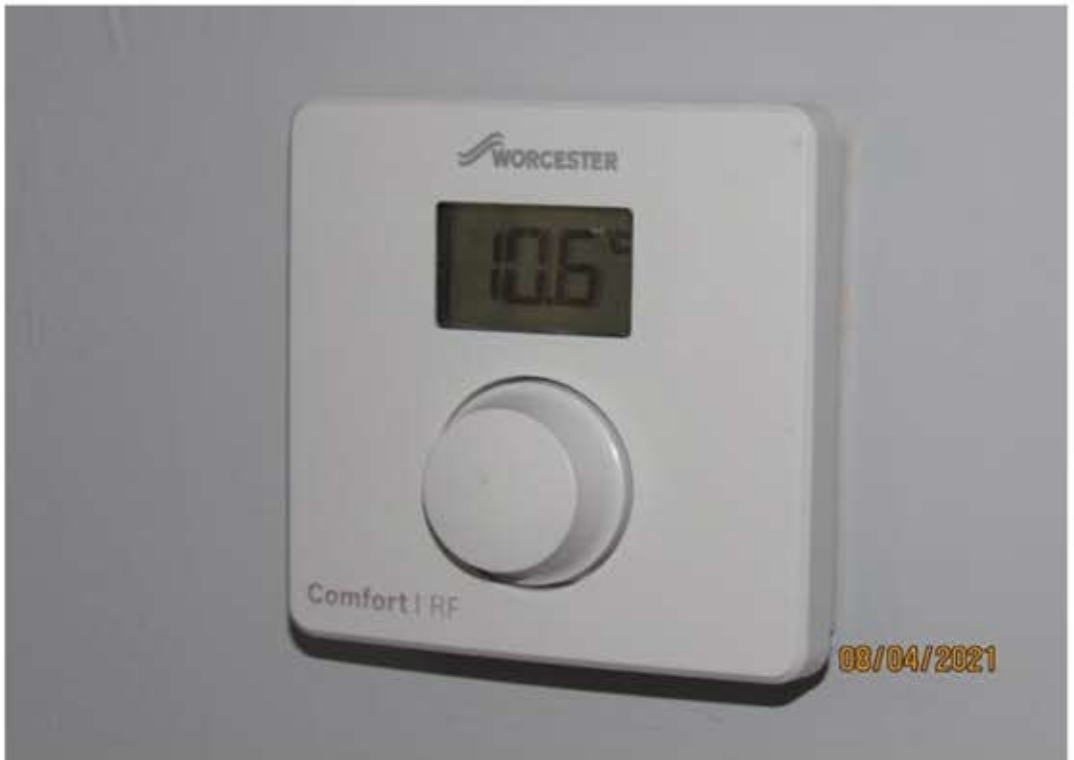
Heating thermostat in utility

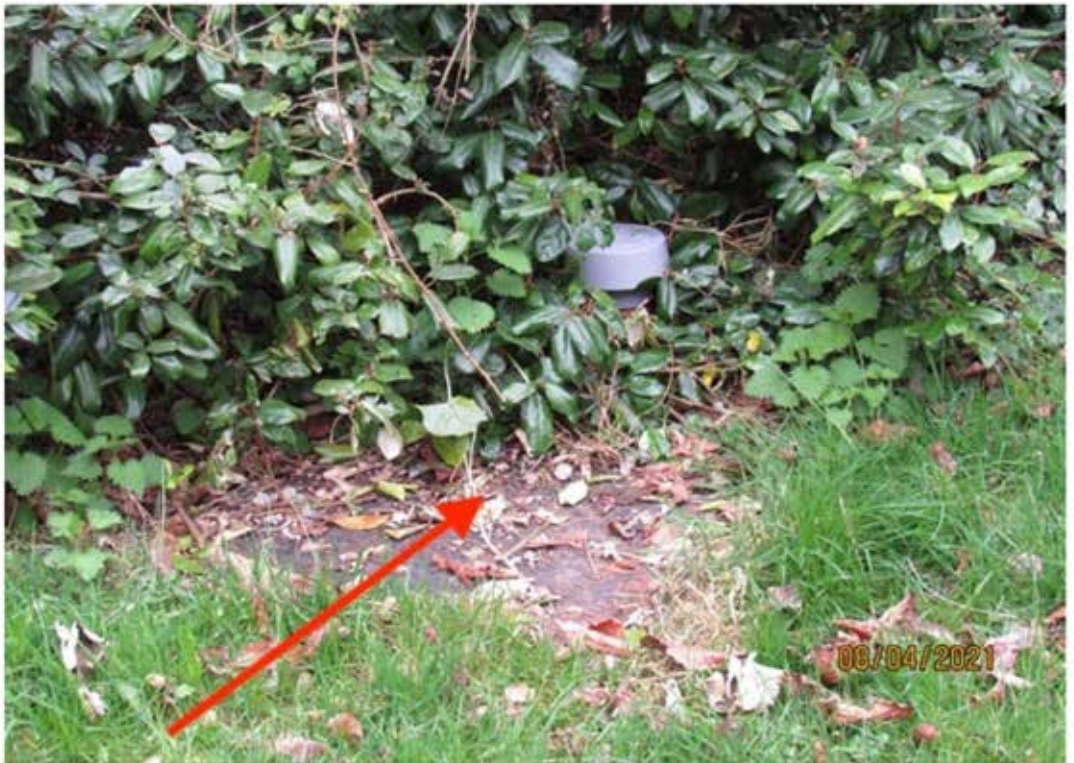
The septic tank was not found due to bush and plant growth in the garden, therefore an inspection was not possible to determine if it complies with the 'General Binding Rules' which came into effect on the 1st January 2020.

It is likely that the septic tank was first installed when the property was built, which suggests it may be in an aged and poor condition.

Estimated position of septic tank in garden

<p><b>Action Required</b></p>	<ol style="list-style-type: none"> <li>1. Commission a CCTV inspection of the drainage system to confirm the overall condition of the pipes and any areas of leakage or blockage. <b>The inspection should be carried out by a qualified contractor, for example a member of the National Association of Drainage Contractors, prior to exchange of contracts.</b></li> <li>2. Request estimates from drainage contractors for the repair work required to the inspection chambers and any other defects found during the CCTV inspection.</li> <li>3. It is very important to know when the septic tank was last emptied and also when it was last inspected/surveyed, ideally by a British Water accredited drainage contractor.</li> <li>4. Ask the drainage contractor to confirm if the rainwater and condensate are feeding in to the septic tank.</li> <li>5. Request estimates from drainage contractors and sewage treatment equipment suppliers to replace the old septic tank with a new tank or a sewage treatment plant such as a Klargester Bio-Disc.</li> <li>6. Drains should be regularly inspected to ensure they remain free from blockages, tree root damage or other obstructions.</li> <li>7. Both the current drainage system and any replacement must comply with the 'General Binding Rules'. If the Environment Agency finds evidence that the septic tank is discharging to a surface water course and is causing pollution, you will need to replace or upgrade the system. You will usually have to do this within 1 year, although this will be agreed on a case-by-case basis. To meet the requirements you may be able to: <ul style="list-style-type: none"> <li>- connect to mains sewer – where available</li> <li>- install a drainage field (also known as an infiltration system) so the septic tank can discharge to ground instead</li> <li>- replace your septic tank with a small sewage treatment plant</li> </ul> </li> <li>8. The responsibility for the replacement or upgrade of the existing treatment system should be addressed between you and vendor as a condition of sale.</li> </ol>

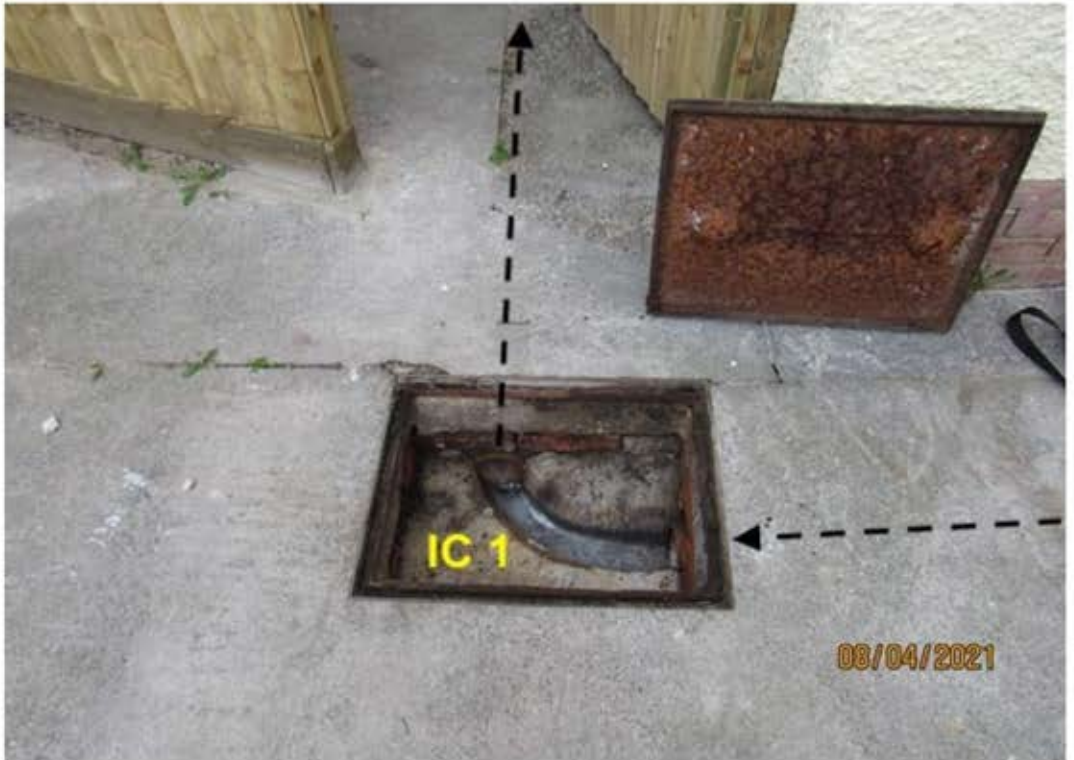
The brick chamber walls in both IC 1 and IC 2 are in very poor condition:

- a) Spalling bricks
- b) Missing mortar
- c) Cracking to the clay pipe

These defects increase the risk that untreated foul water is leaking into the ground in this area and must be addressed.

Drainage inspection chamber near north-east corner (IC 1) and estimated position of pipework

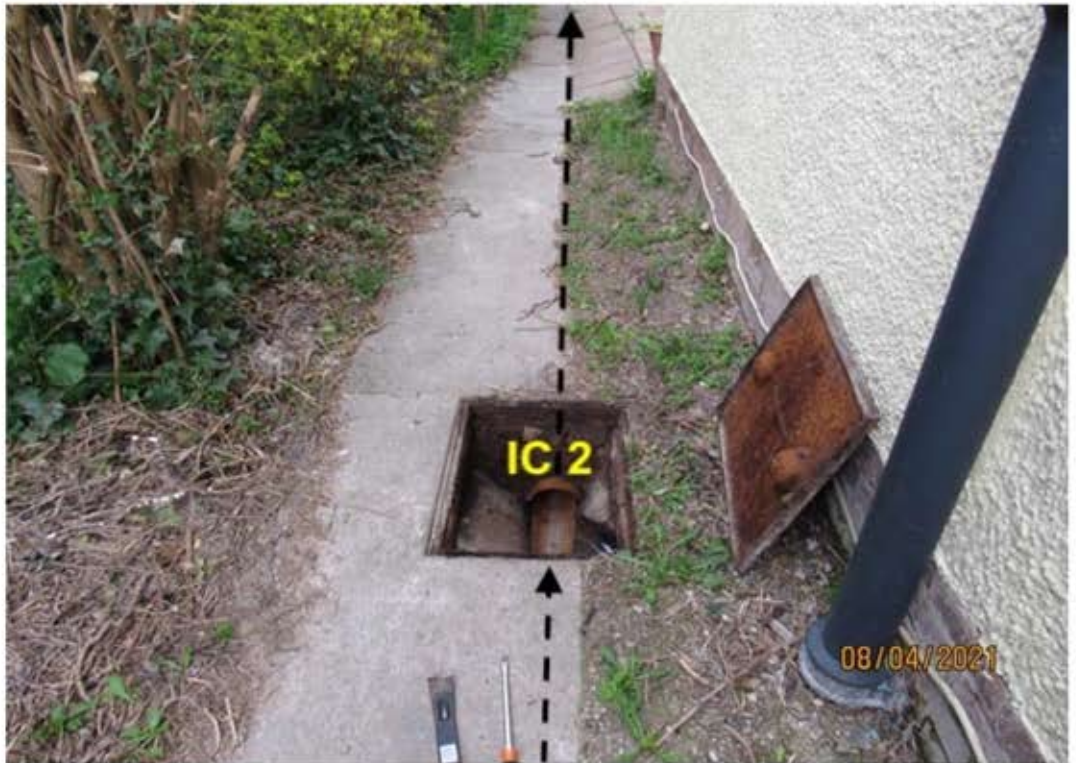
Drainage inspection chamber near east wall (IC 2)

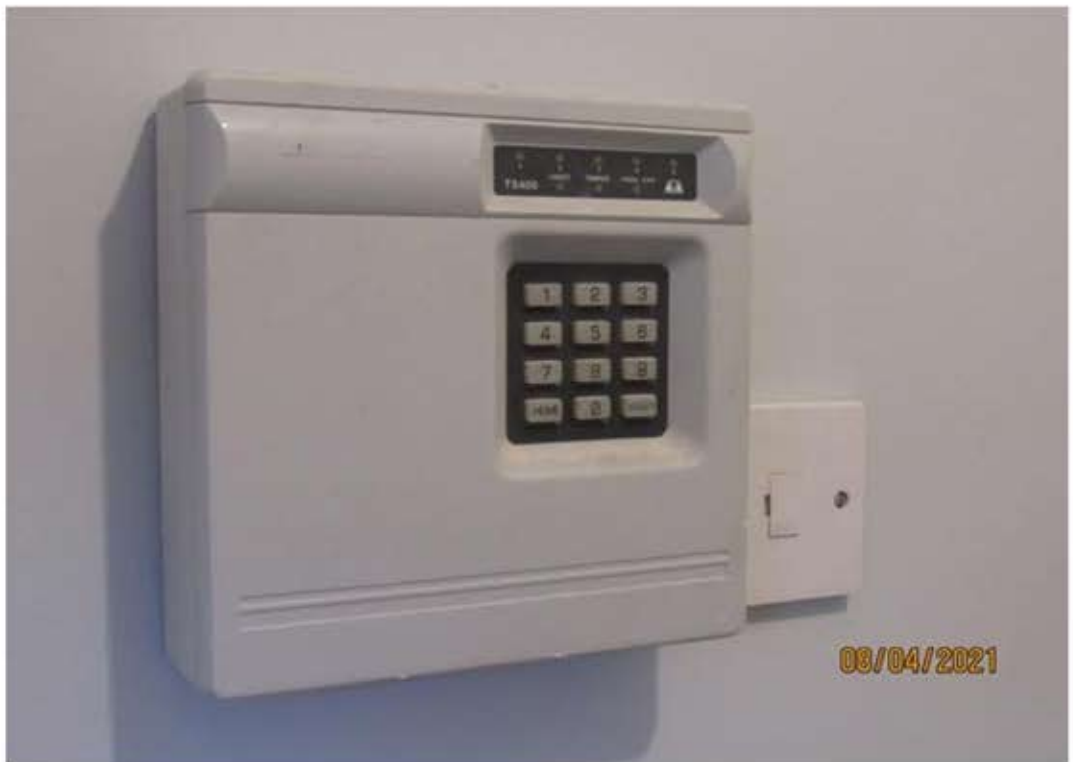
Intruder alarm in cloakroom
