**Mi BUILDING SURVEY**

# BUILDING SURVEY REPORT

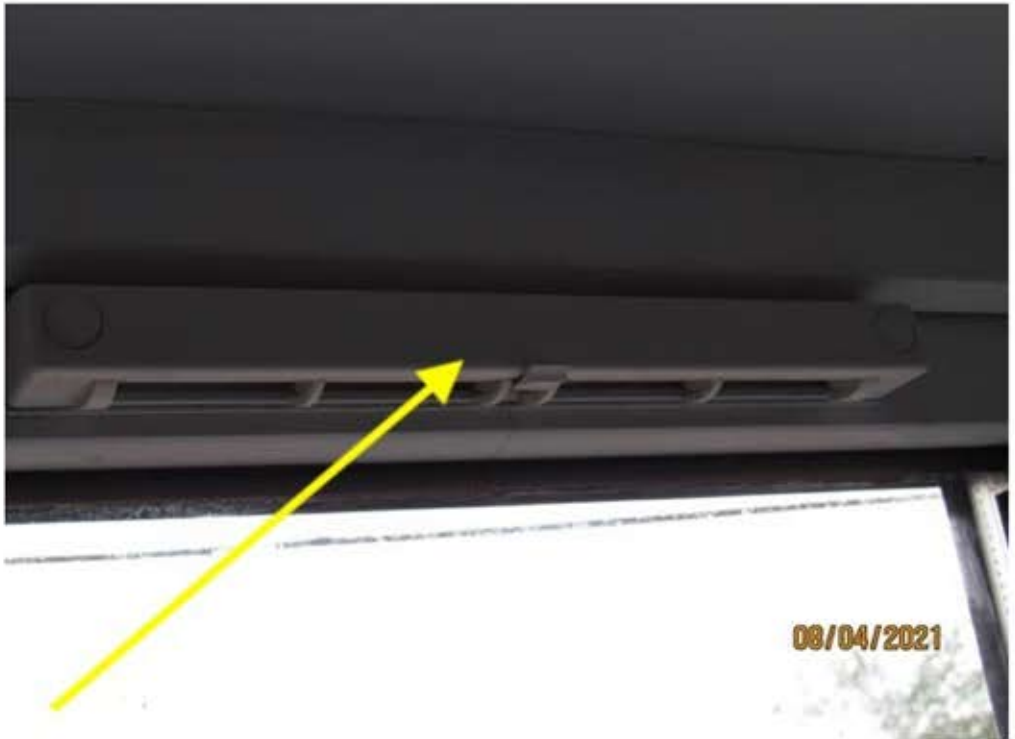
Trickle vents above one bedroom 1 window

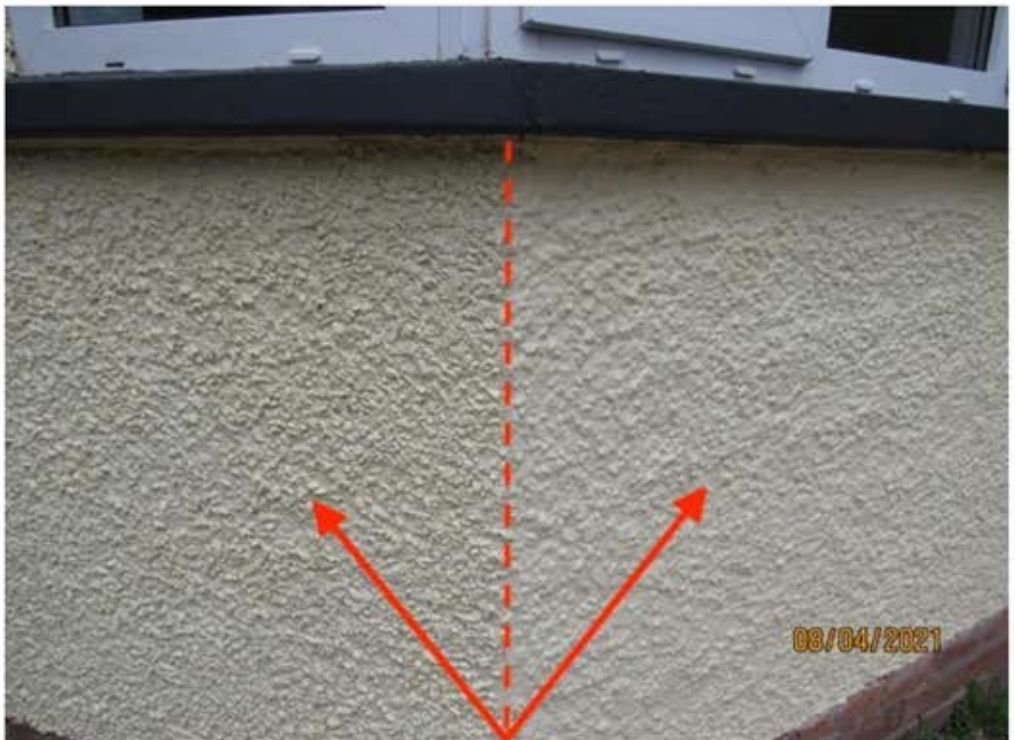
Different renders applied to walls below west bay window

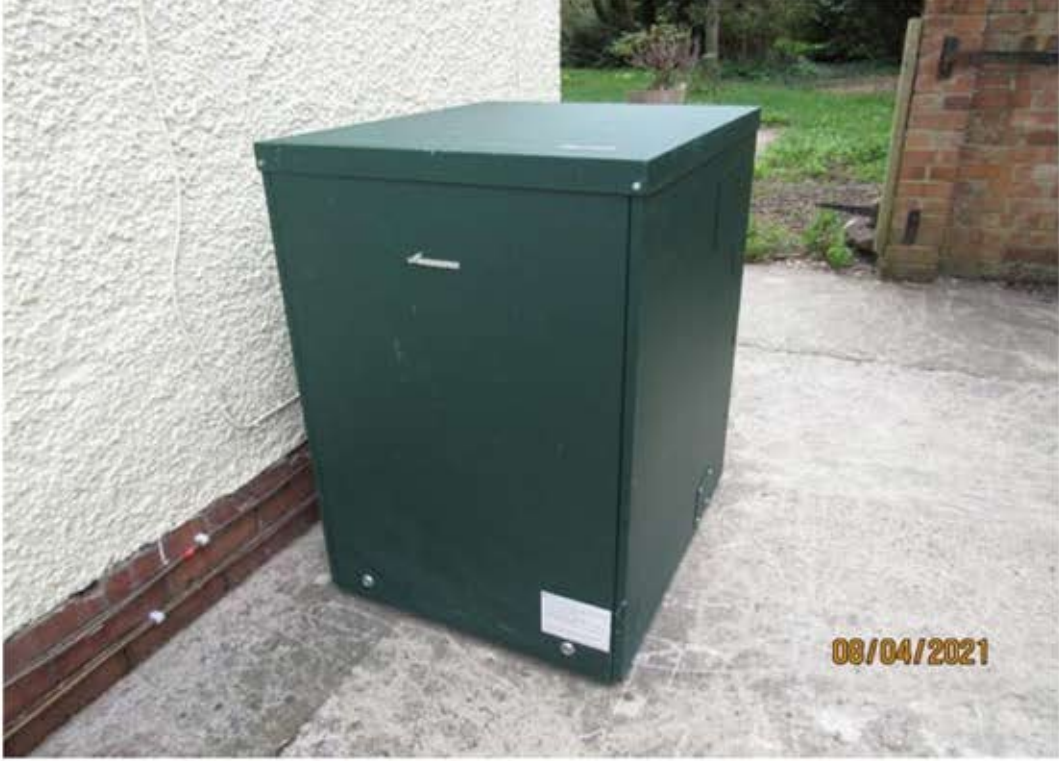
<p><b>Condition</b></p>	<p>No obvious or significant defects were noted.</p> <p>As mentioned in section 6.2 Gas / Oil, OFTEC recommends that all oil appliances, storage vessels and boilers are inspected and serviced according to manufacturer's guidance, but at least once a year, by a competent person (OFTEC registered technician).</p> <p>As previous mentioned, the 'CD/11 oil firing servicing and commissioning report' form was found but was completed by a Non-OFTEC Registered Technician.</p> <p>What is included in an annual oil boiler service?</p> <p>An annual oil boiler service should only be performed by an OFTEC registered technician, who will check that the boiler is in good working condition, as well as testing the safety and efficiency of the system.</p> <p>During the service, the OFTEC technician will:</p> <ul style="list-style-type: none"> <li>- Visually inspect the boiler and all associated pipes or areas (including the oil storage tank and supply pipe), to make sure that they comply with current safety regulations.</li> <li>- Inspect and clean out the flue.</li> <li>- Replace the boiler nozzle.</li> <li>- Check for water in your oil tank.</li> <li>- Use a flue gas analyser to check combustion.</li> <li>- Check the supply pipe for any signs of leakage.</li> <li>- Remove the boiler casing and clean internal components (like the heat exchanger and burner).</li> <li>- Test all safety systems to make sure that they are functioning correctly (this includes any thermostats, pressure relief valves and burner lockout devices).</li> <li>- Turn the boiler on to check that it is working correctly.</li> </ul> <p>The radiator system was not in operation during the survey, but the hot taps were tested and hot water was delivered.</p> <p>No evidence was seen to suggest that an inhibitor (magnetic filter) has been added to the heating system recently to prevent a build-up of sludge in the pipework and radiators which will improve efficiency.</p> <p>Combination boilers can only provide hot water to one appliance at a time (usually the appliance closest to the boiler). Consequently, if there is more than one demand for the boiler at a time the appliances further away can get reduced levels of hot water. It can also take longer to fill a bath than with a traditional system.</p> <p>Condensing boilers produce a slightly acidic waste product called condensate which is removed via a plastic pipe to an external drain. If the pipe becomes blocked, perhaps by liquid freezing within it, it can cause of the boiler to shut down.</p> <p>The condensate pipe was seen to connect to the rainwater gully near the south-west corner of the property. Condensate must not feed in to the septic tank. This is discussed further in section 6.5 Drainage.</p> <p>Condition rating:</p> <p><b>A Health and Safety HS rating has been applied to this section due to the requirement for the oil-fired boiler to be inspected and tested prior to exchange of contracts.</b></p>

<p style="text-align: center;">External oil-fired heating boiler</p>

<p><b>Action Required</b></p>	<p>1. Ask your legal adviser to confirm the existence of current safety/testing certification for the oil-fired boiler installation.  - An oil installation can look to be in a safe condition, but serious defects may be hidden, some of which can kill.  <b>It is therefore considered to be essential that you commission an inspection of the oil-fired boiler prior to you making a legal commitment to purchase the property, unless you are provided with verifiable evidence that such an inspection has recently been carried out by an OFTEC registered technician.</b></p> <p>2. If one is not already present, it is recommended that the heating system is flushed through and an inhibitor added.</p> <p>3. The condensate may have to be discharged in to a separate drain such as a condensate soakaway. This is filled with lime chippings and enables the controlled release of condensate from the boiler into the ground.</p> <p>4. Normal maintenance including commissioning annual servicing by an OFTEC engineer must be continually undertaken.</p> <p>5. Health and Safety – See notes in section 6.2 Gas / Oil, regarding the general safety and servicing of the complete oil installation.</p>

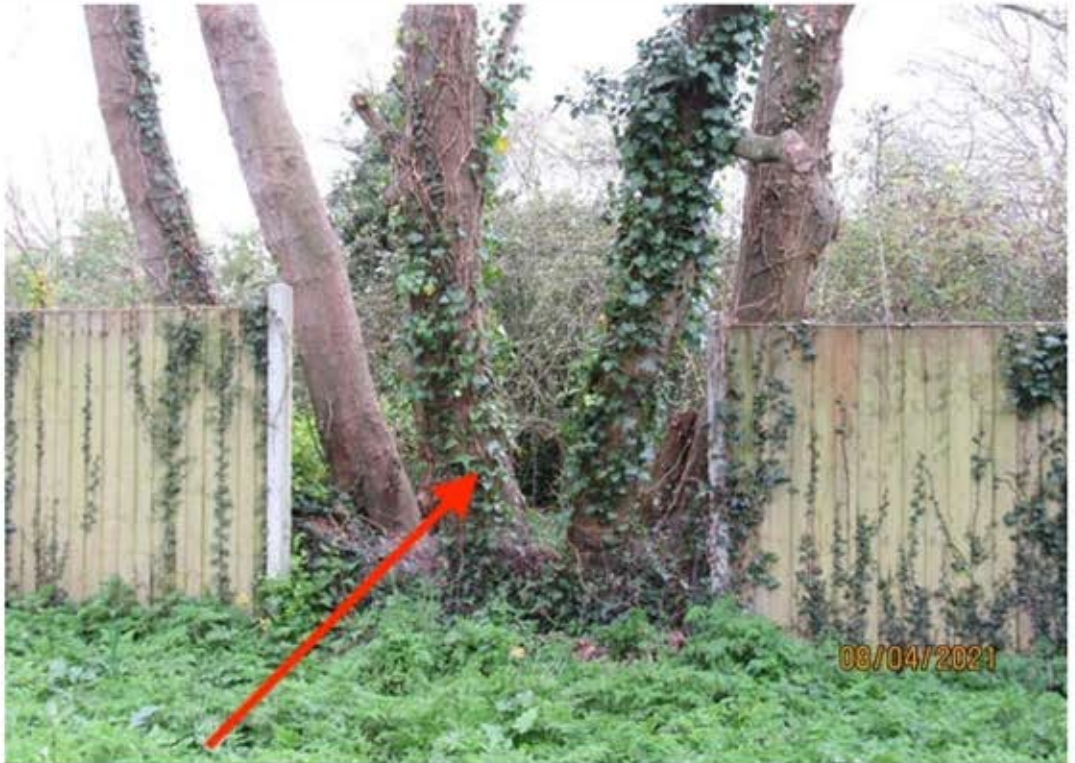
Mature tree growing on west boundary

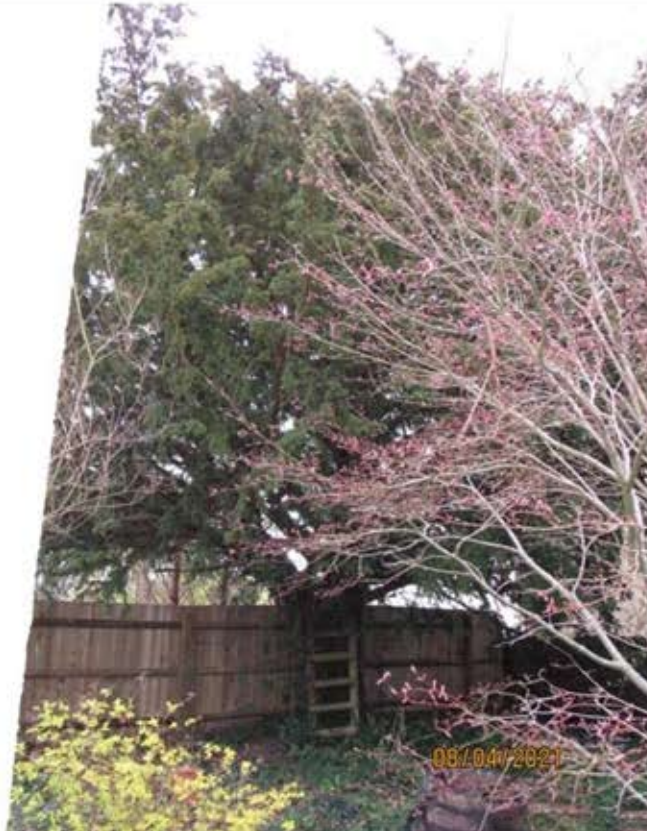
Mature yew tree on east boundary
